7/20/2021

I am assisting Mr. Brad Fuster in resolving the issues with respect to the removal of 14 dead or dying ash trees in a deed-restricted area on his property located at 3663 Summit Vw, Canandaigua, NY 14424.

Trunk sizes and stump heights of the 14 removed ash trees

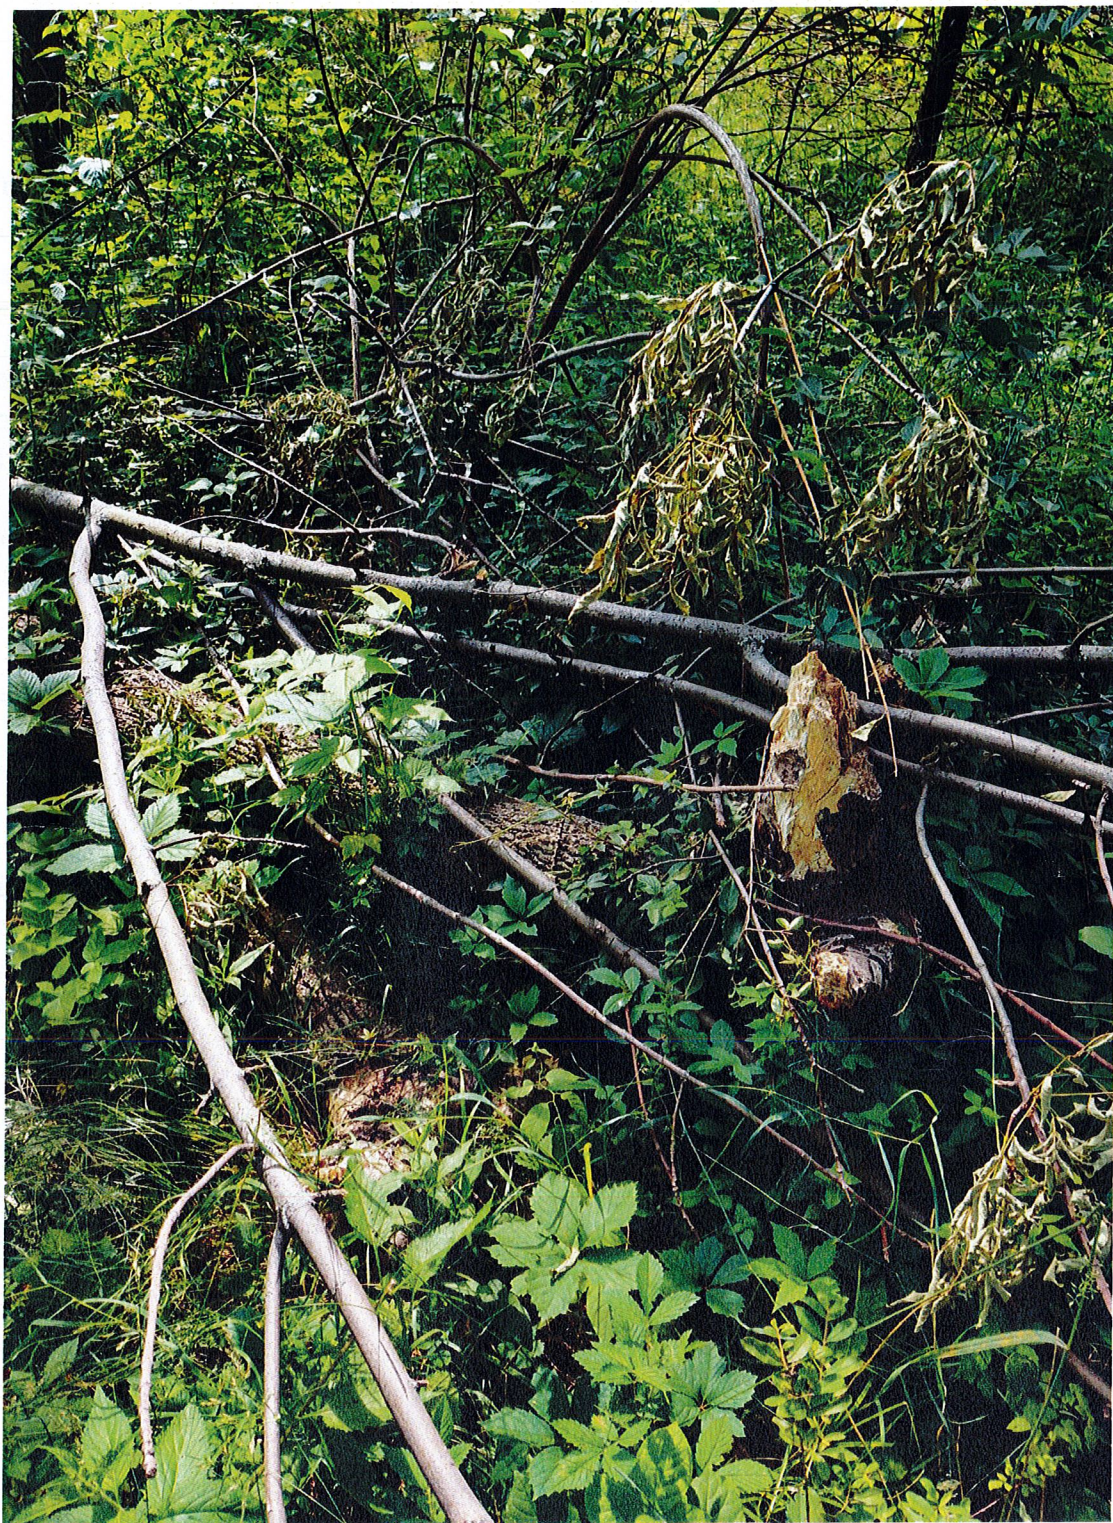
As an example, the ash tree shown below was found on the property and had been previously blown over due to high wind and a dead root system, resulting from EAB damage.

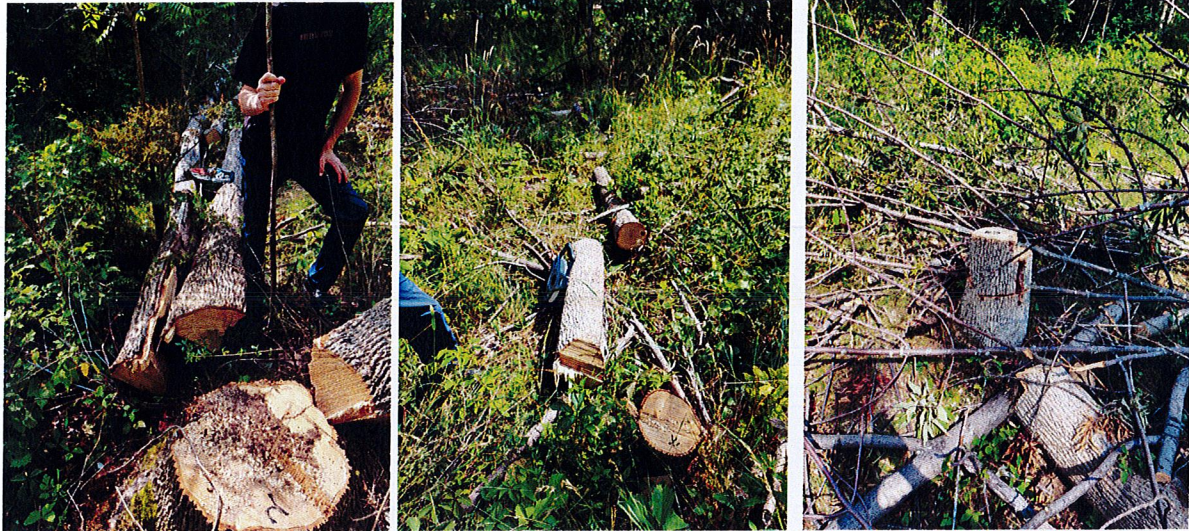
Tree 1 and Tree 12: Had extensive evidence blanding and EAB damage on the bark. These trees were not going to survive and were hazardous if left standing.

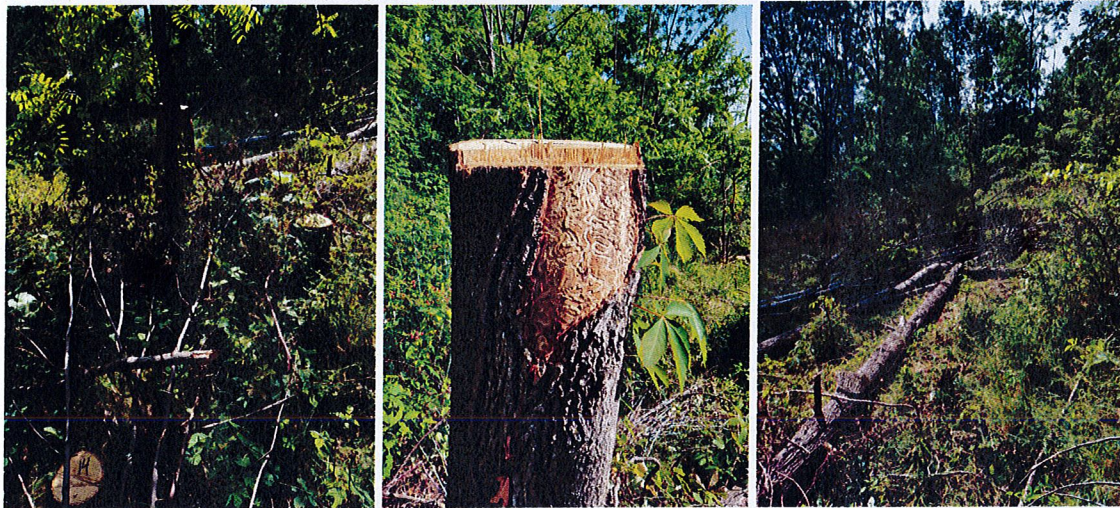
Tree 2, Tree 7, Tree 3: Had extensive evidence blanding and EAB damage on the bark. These trees were either dead or not going to survive and were hazardous if left standing.

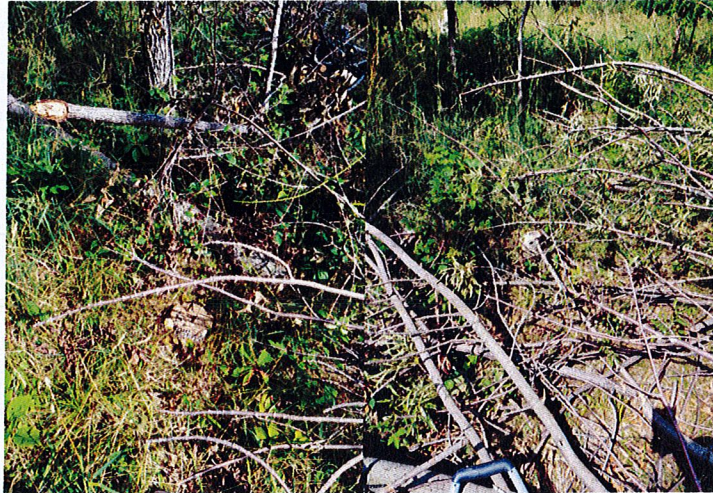
Trees 4,5,6, Tree 10, Trees 11, 13, 14: Had extensive evidence blanding and EAB damage on the bark. These trees were dead and were hazardous if left standing. The stump of tree 10 has the clearest emblematic example of blanding left by the Emerald Ash Borer (EAB).

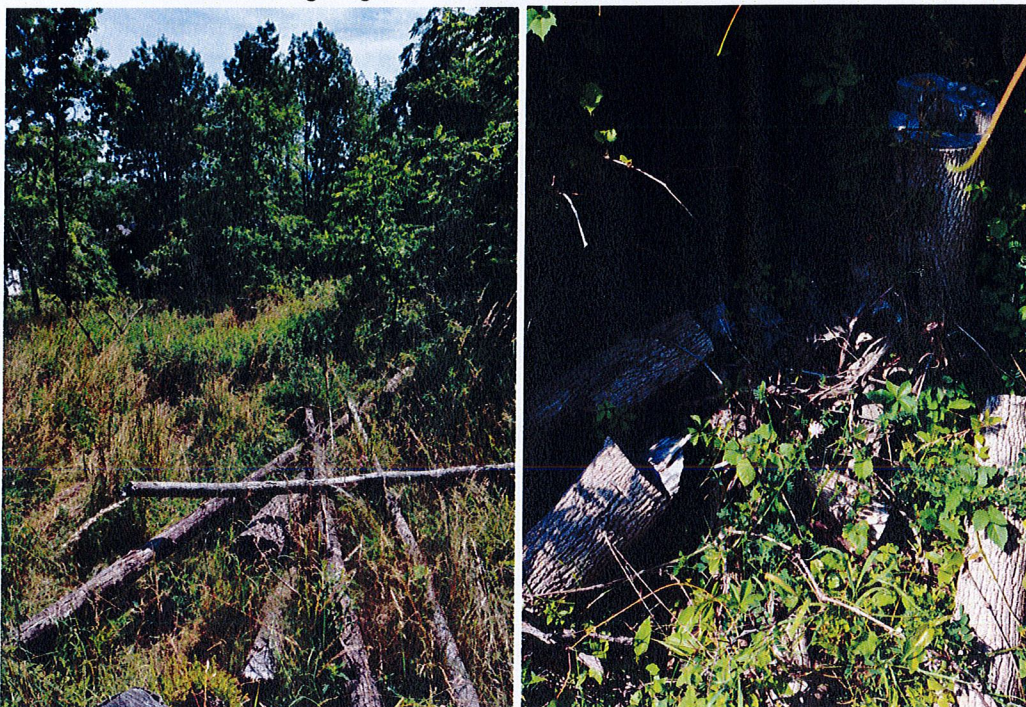
Tree 8 and tree 9: Had extensive evidence blanding and EAB damage on the bark. These trees were dead or not going to survive and were hazardous if left standing.

The above trees show old cuts due to the grey color of the wood. These cuts were made years ago and not at the same time as the 14 trees described in detail above. After speaking with the homeowner and reviewing the aerial images included "Notice of Violation" that were dated 3/30/2021 and 4/22/2018, it is clear that the property has had additional trees, beyond the 14 dead or dying ash trees noted in the included table. According to the homeowner, the trees noted above and intimated in the aerial photos were removed by the previous property owner. The current homeowner has occupied the premises since 11/1/2019.
