## Finger Lakes Community College Area Storm Water Management Study

August 2006

# **STORM WATER MANAGEMENT STUDY AND SCHEMATIC DESIGN WITHIN TWO WATERSHEDS IN THE AREA OF FINGER LAKES COMMUNITY COLLEGE ONTARIO COUNTY, NEW YORK**

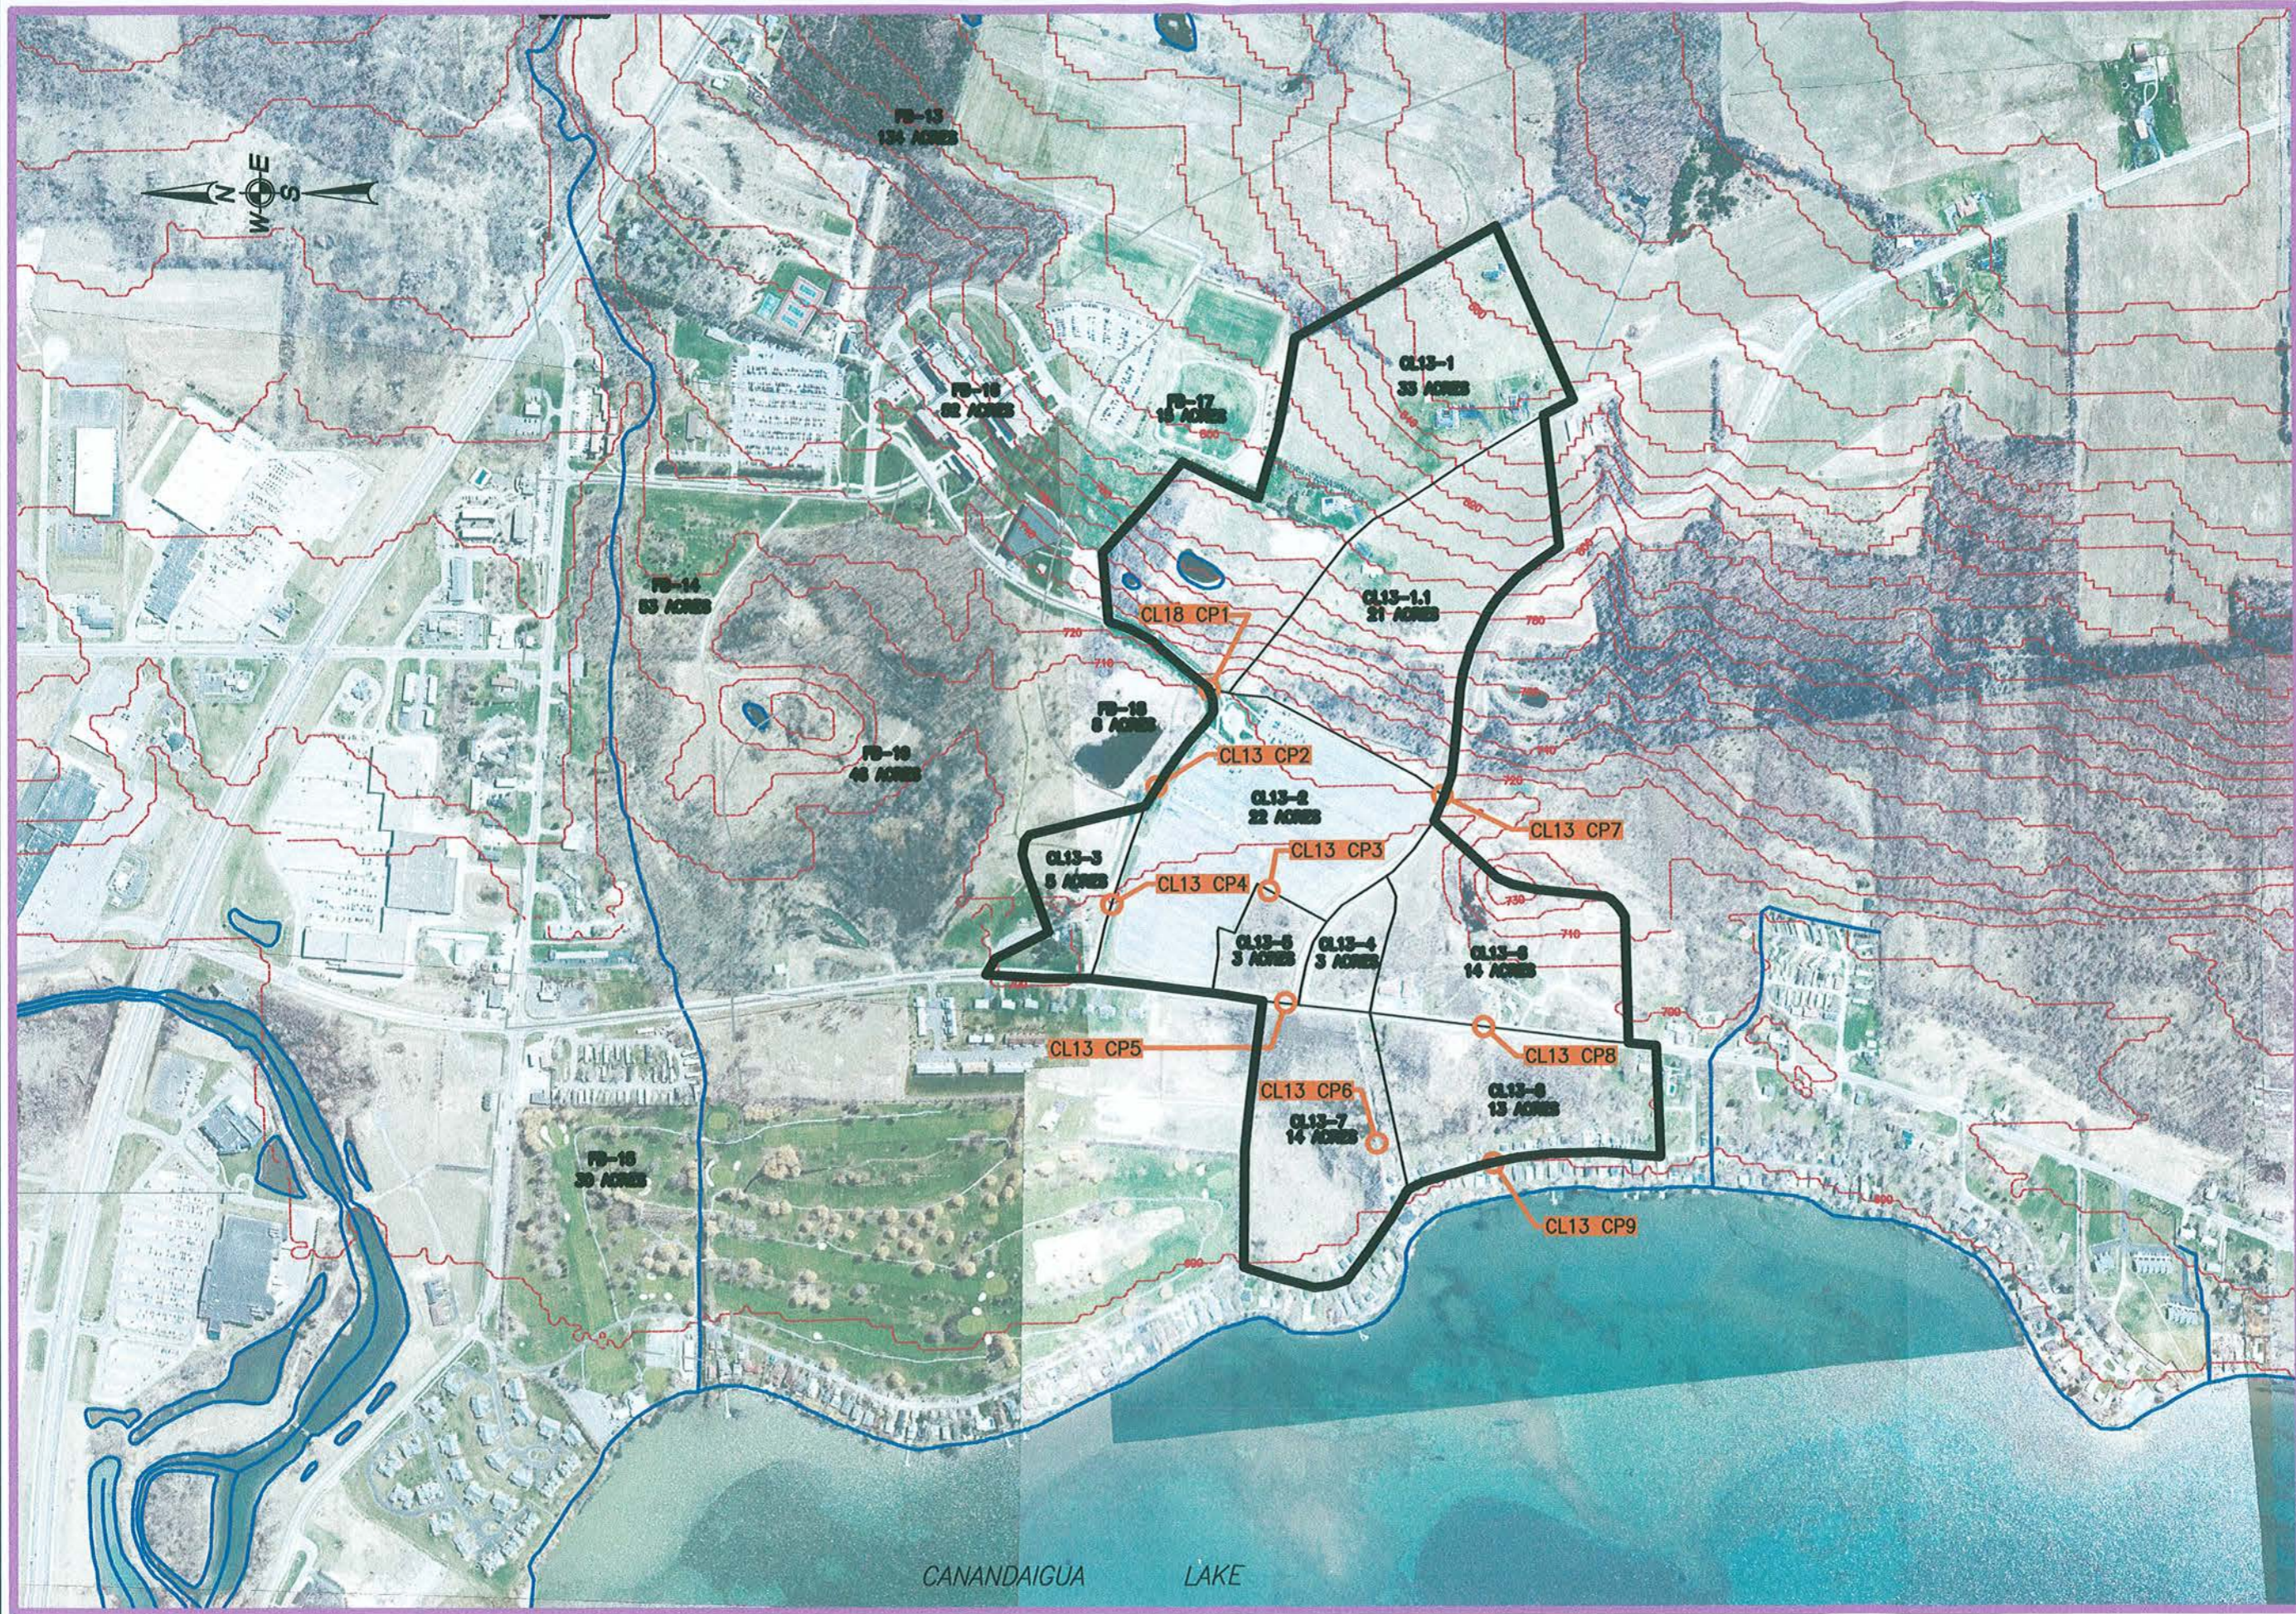
DRAWING NO. **G 101**

The complete watershed map of CL-13 is presented in Drawing G101. CL-13 will include the site of the proposed Auditorium Building at the Community College as well as the FLPAC's existing parking lot and the Lincoln Hill Inn. CL-13 extends easterly into Hopewell and is bounded by the north side of CR 18 and then includes property on both sides of NYS Rt. 364 from the Poplar Beach to just north of the Sandy Beach access drives. The actual lake front properties are shown to drain directly to the lake for the storm water model's purpose in determining runoff to the control points shown. The CL-13 watershed is 123 acres in area.

As a part of this study and at the request of the County an additional analysis relative to provision of outlets to the Lake was done of an 8acre drainage area in Sandy Beach at the southern end of subarea CL13-8 as depicted on the CL-13 Watershed Plan in Section IV of this study. This was done to determine if the existing pipe that crosses between the Lucey and Welch properties could be able to handle runoff from this area if it were to be isolated from the rest of the watershed. The result of the analysis indicated that a 15-inch pipe at this location might be adequate. The condition, size and grade of the existing pipe at this location from its inlet to its outlet must be verified before this determination can be made.

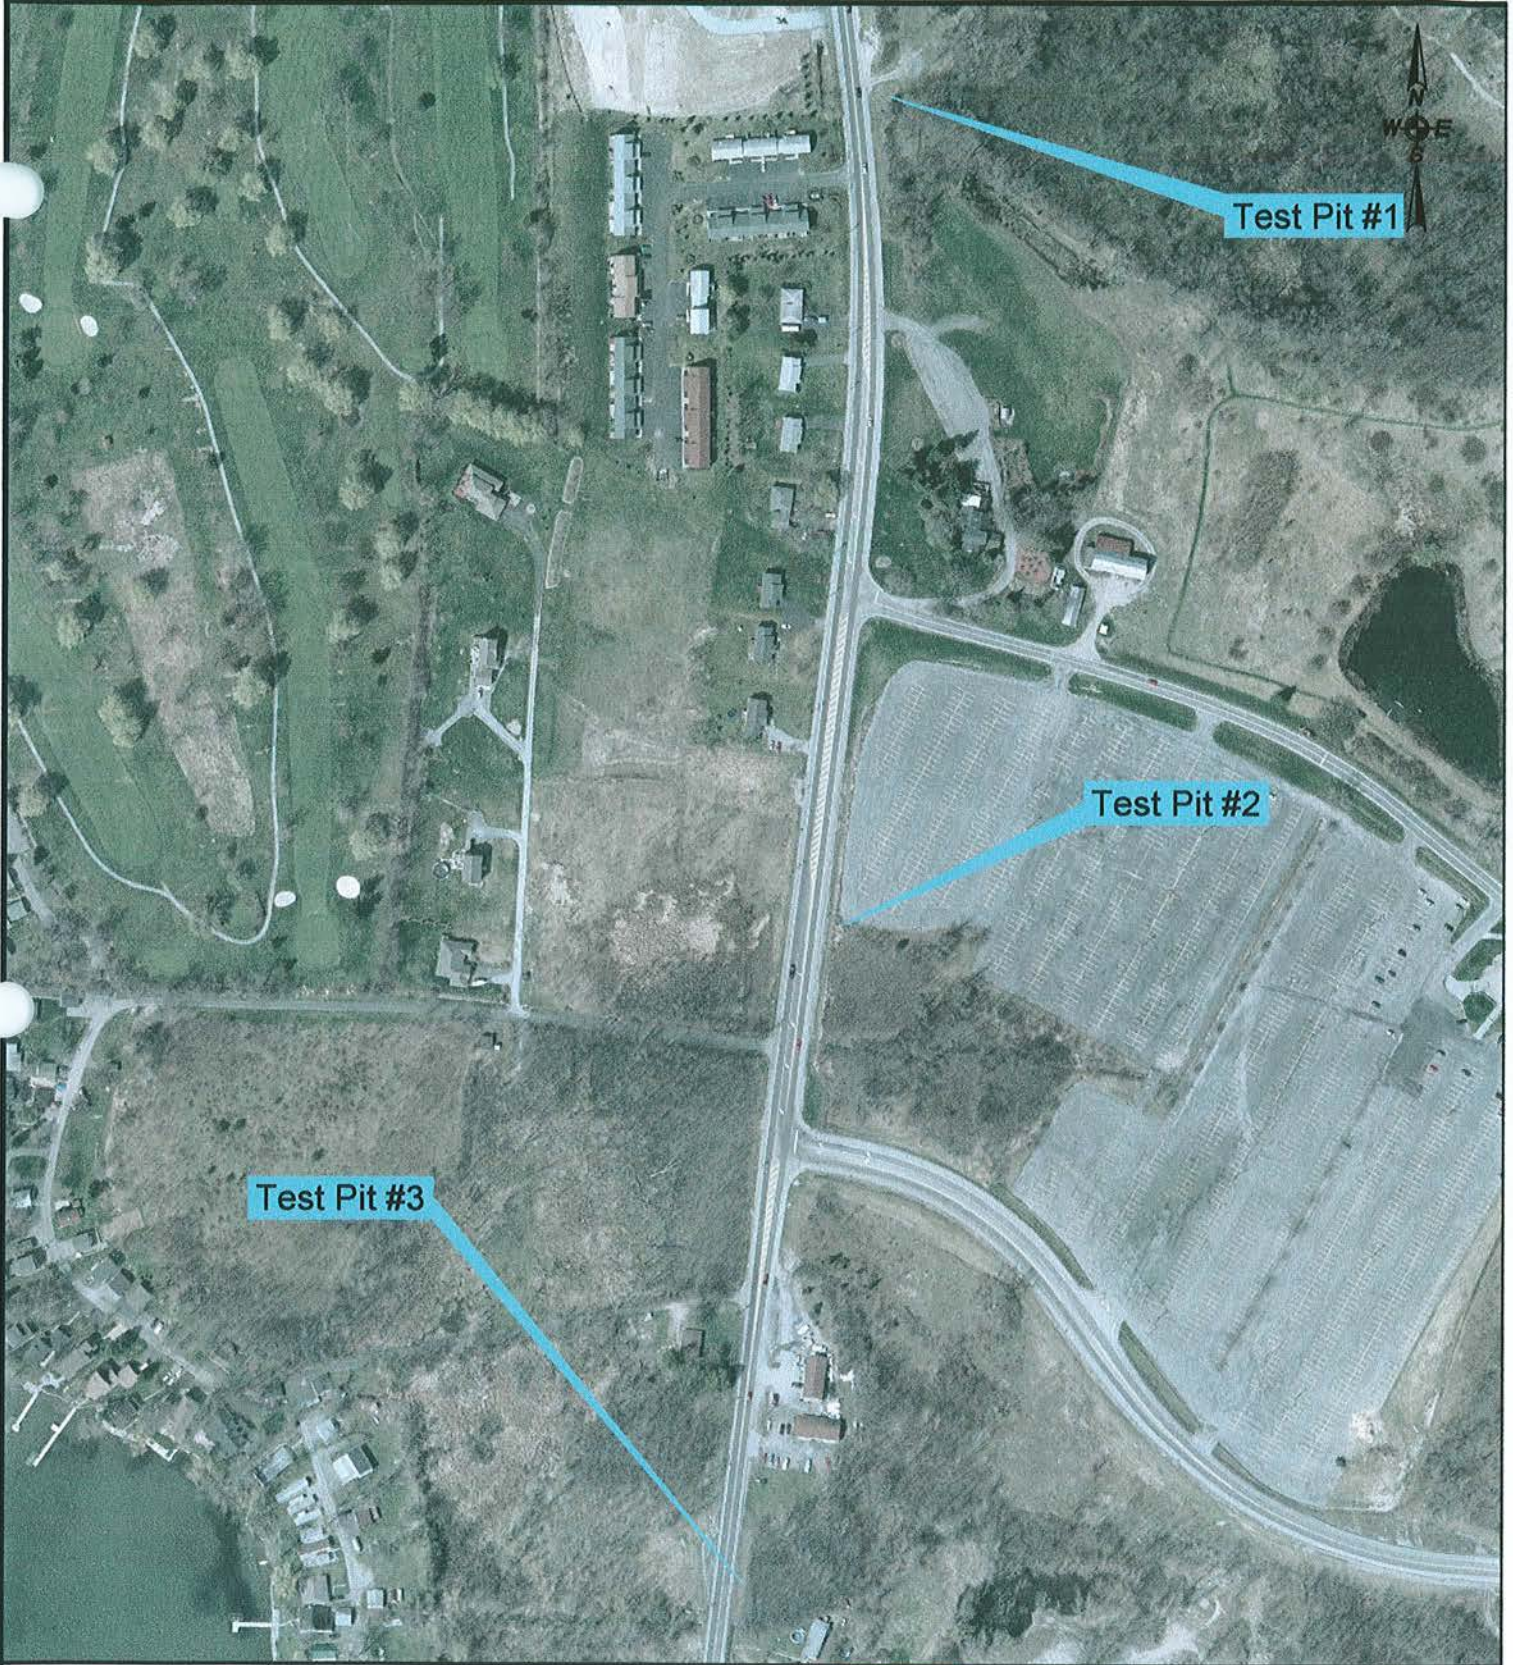
The County's Highway's Department excavated three test pits along the east side of NYS Rt. 364 at locations shown in Figure 4. Logs of the results of these test pits are presented in the "Watershed Condition Information" section of the Appendices.

8. Review of the soils data collected from the test pit reports, to the depths that County equipment was capable of excavating, indicate low permeability soils (clay) in the vicinity of CL-13 indicating little potential for substantial subsurface movement of groundwater from upland areas off County owned property into CL-13.

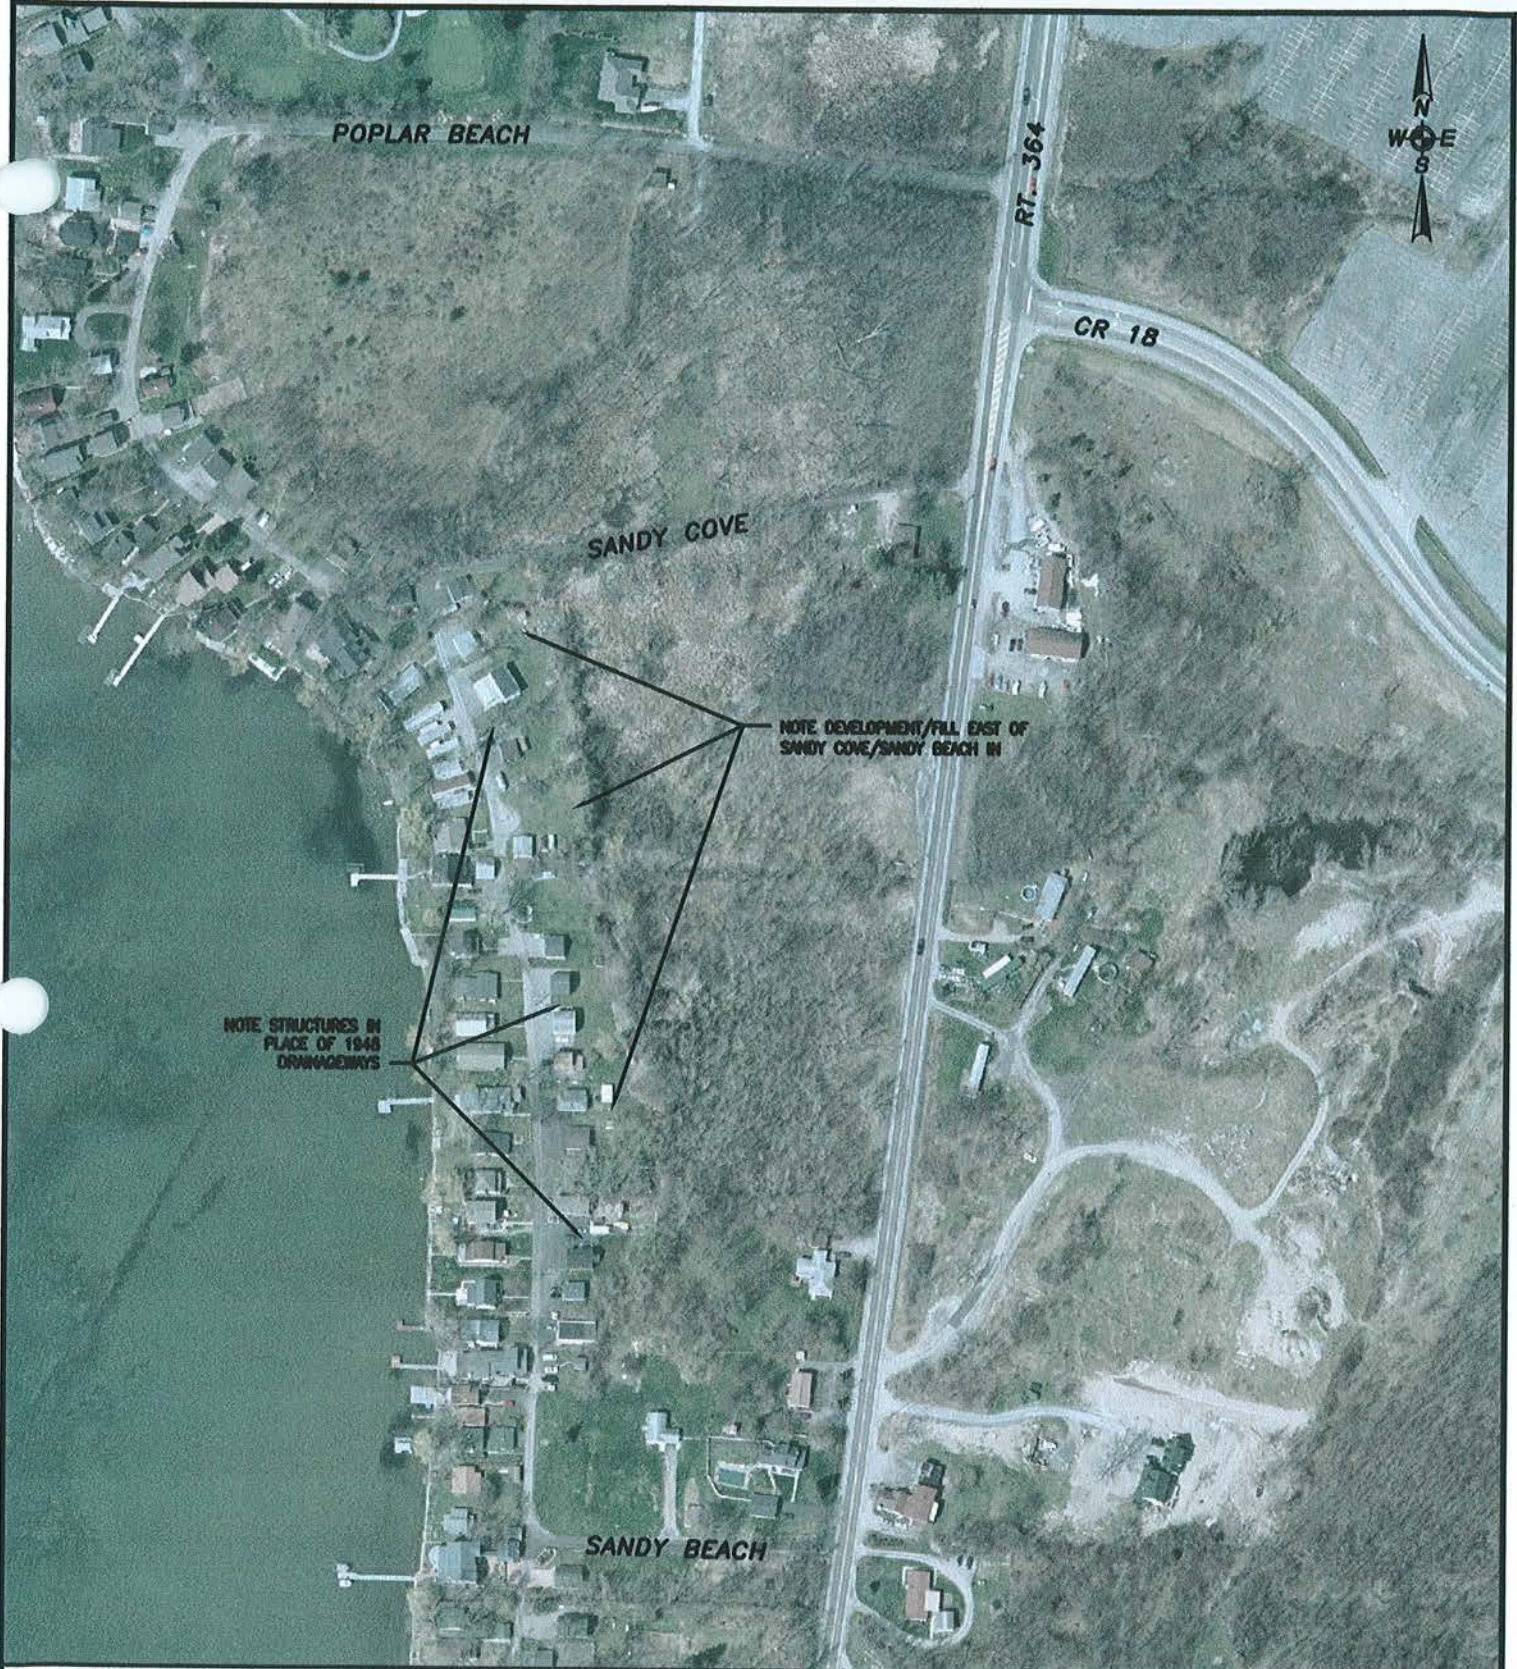
**2005 AERIAL IMAGERY  
 SHOWING STRUCTURES AND FILL**

- Comparison of Figures 2 and 5, which show 1948 conditions relative to 2005 conditions respectively. It is noted that the open drainage ways that existed in 1948 have been replaced by piped systems and that development has advanced east of the lake shore road into the wetland area;

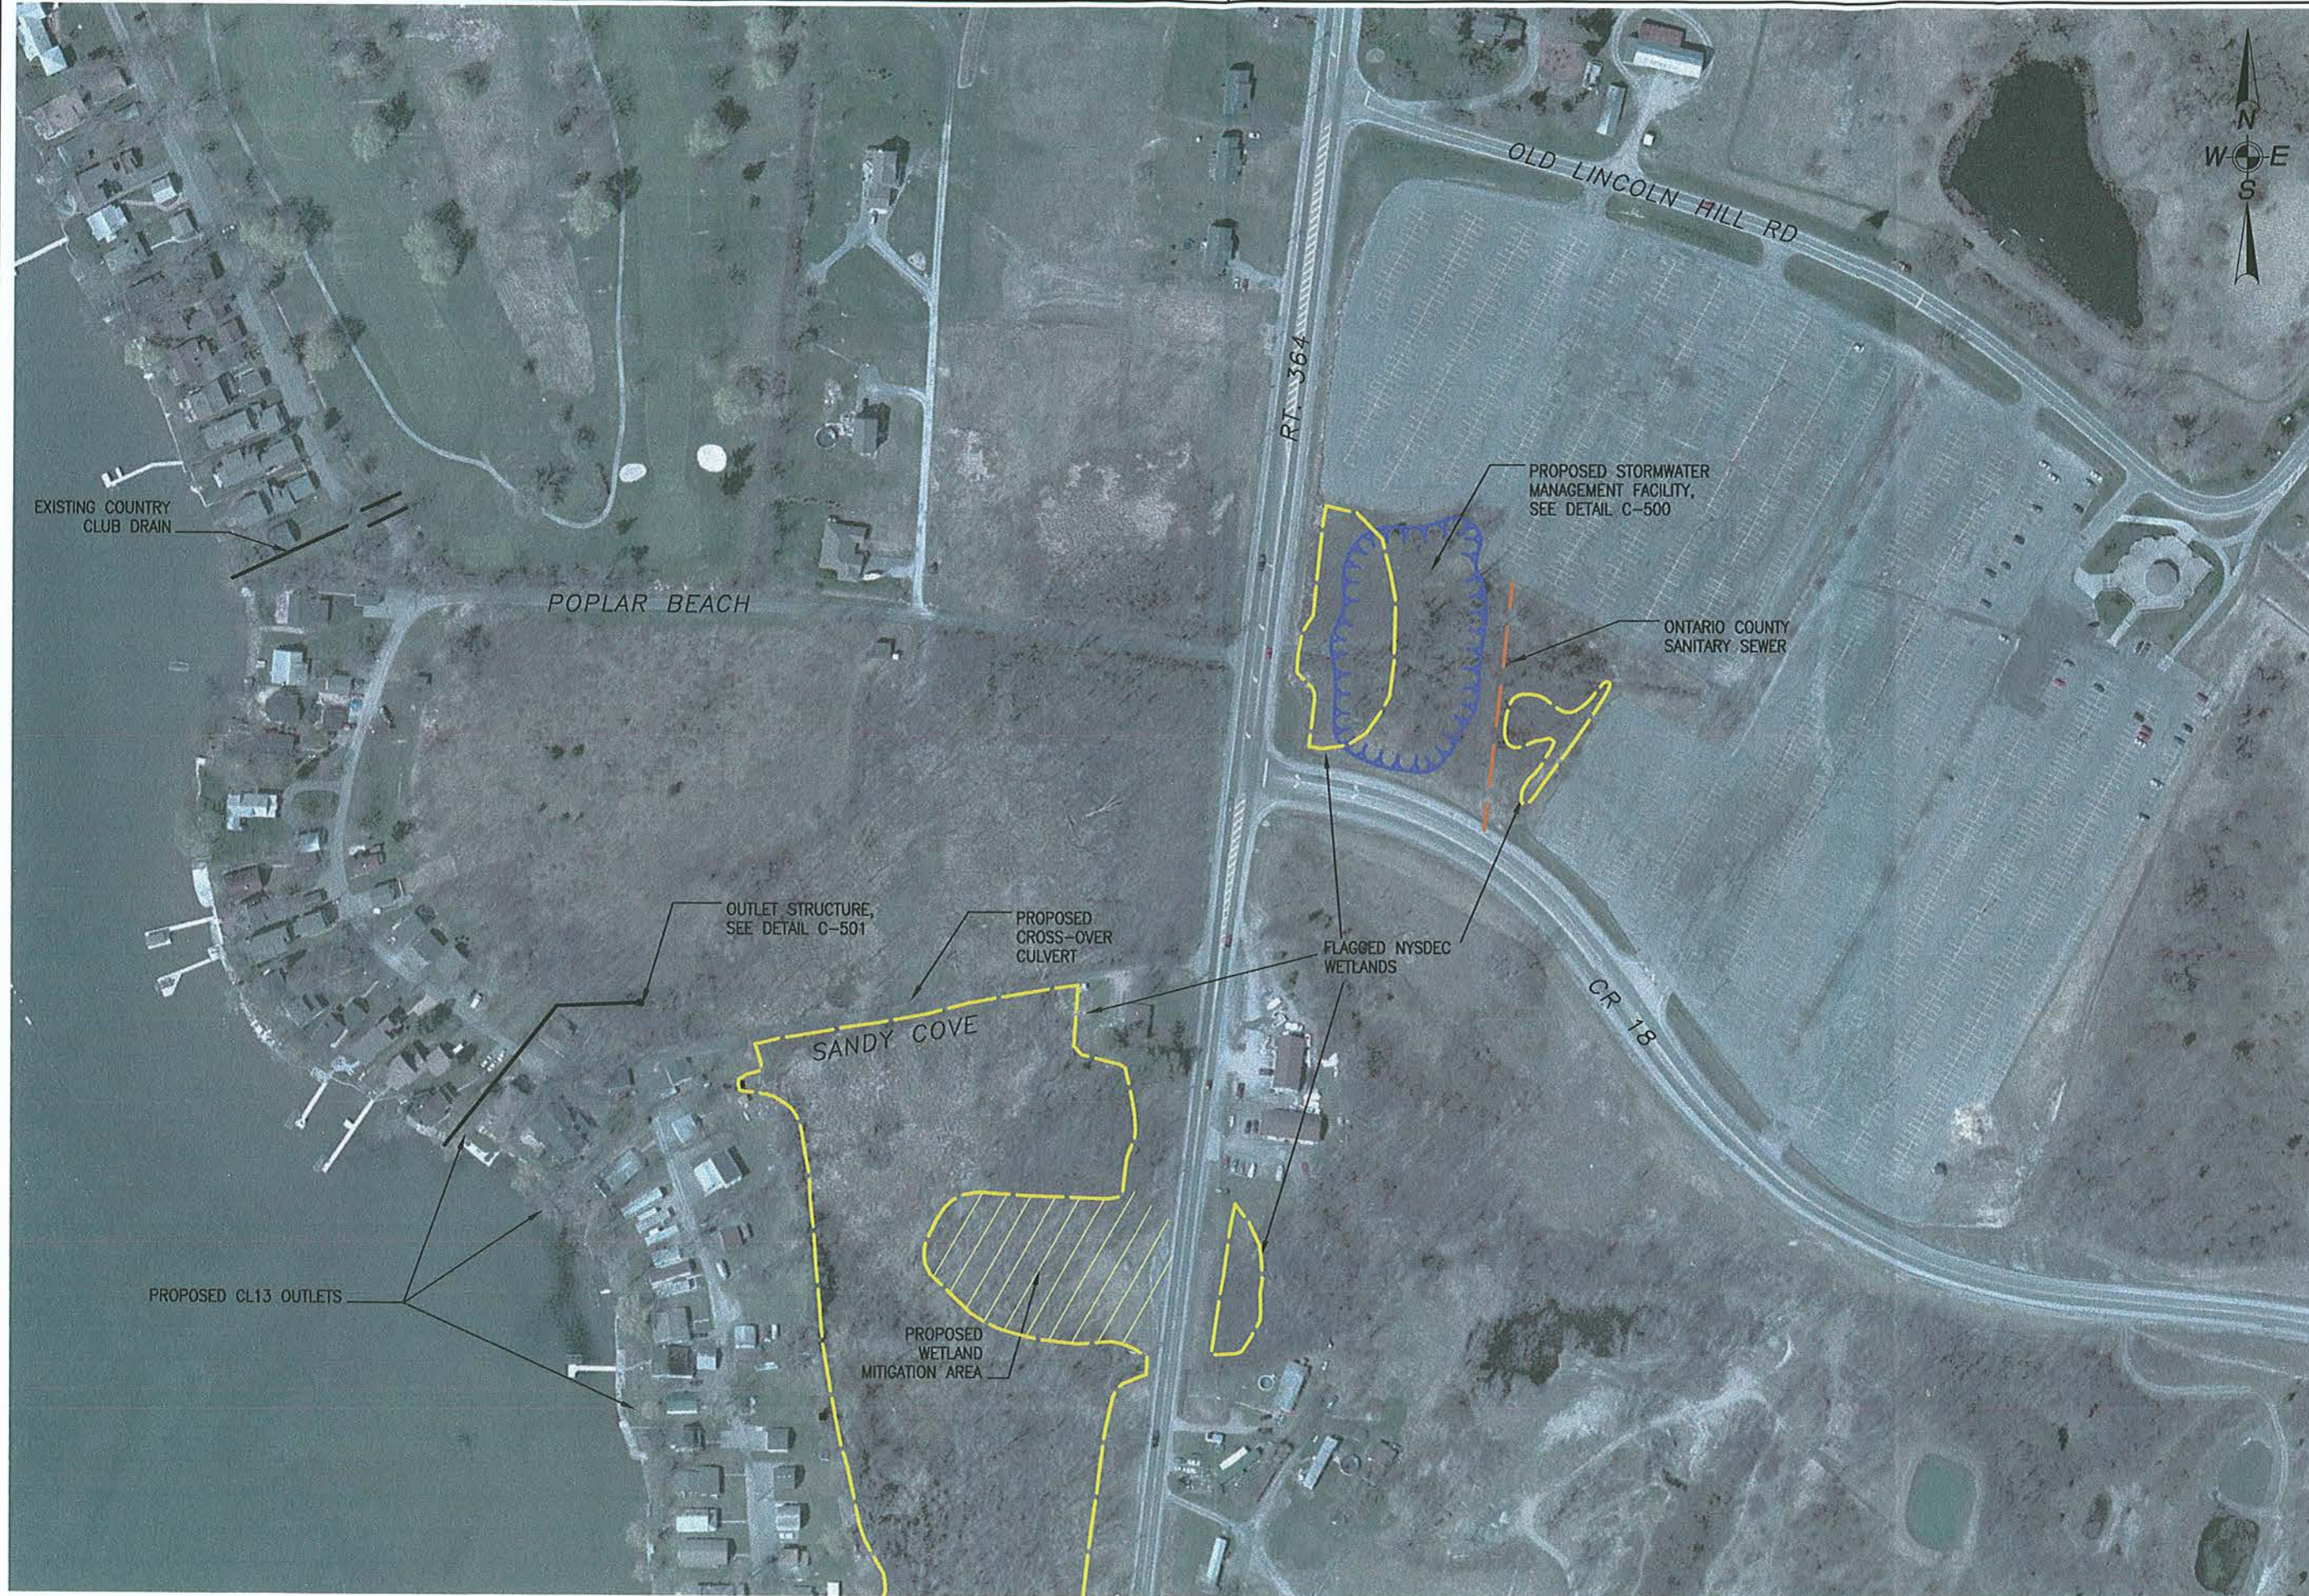
PROJECT: FINGER LAKES COMMUNITY COLLEGE DRAINAGE STUDY  
TOWN OF CANANDAIGUA, COUNTY OF ONTARIO, STATE OF NEW YORK  
TITLE: RECOMMENDATIONS WITH SCHEMATIC DESIGN ALTERNATIVES

The recommendation is for three outlets to the Lake with locations as close to those of historic drainage ways as shown on Drawing C-100. Three outlets as opposed to one or two are proposed mainly to intercept all established drainage patterns without having to regrade within the wetland. In addition multiple outlets will distribute the 29CFS so as to not cause significant disturbance in the Lake at any one point and to better assure the availability of a reliable discharge point. Drawing C-102 shows a detail of a proposed outlet structure that provides the following: regulation of the upland water level through gated multiple drawoff points; an open top grated emergency inlet and a low cover, high volume oval discharge. An estimate of cost for the installation of up to three of these outlets by public contract is presented in Section VIII of this study.
