Federal Wetland Delineation Report

Westbrook - Canandaigua Town of Canandaigua Ontario County New York

Project No. 2089-35 July 2016

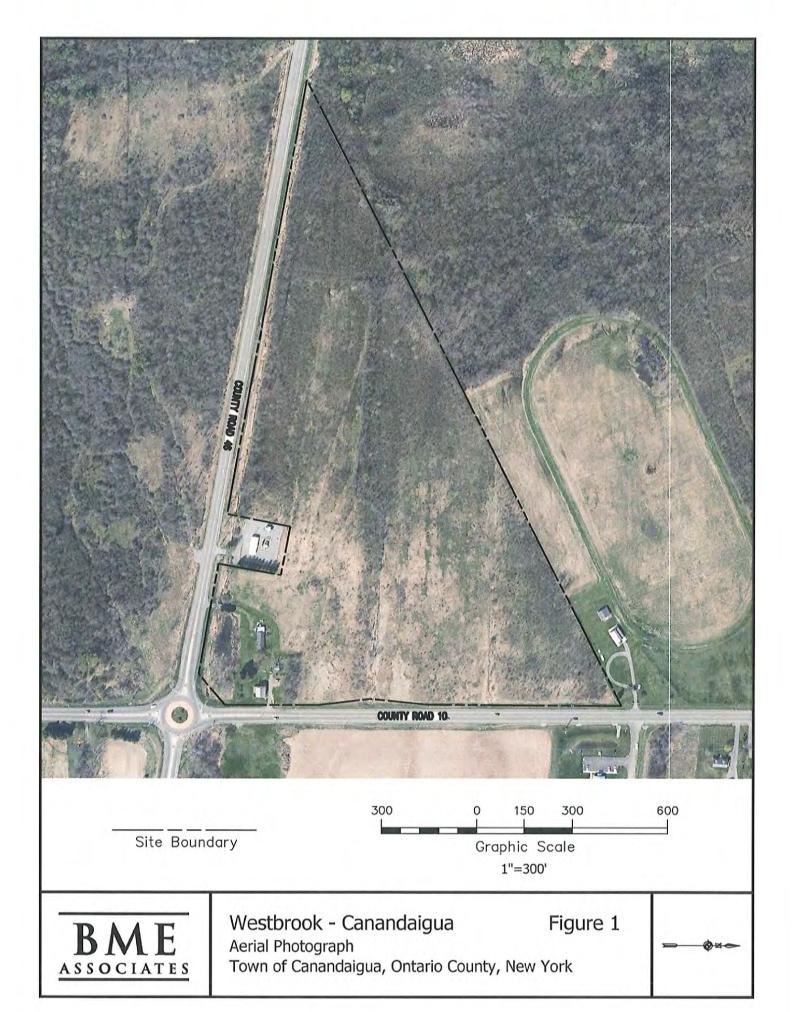
Figure 1 – Aerial Map

- GIS Aerial Photo of the Site (Figure 1) The majority of the site is upland scrub-shrub or early successional forest bordered on the south by Route 46 and the east by Route 10.
- U.S. Geological Survey (USGS) 7.5 minute topographic series was reviewed (Canandiagua Quadrangle) to assist with drainage patterns and the presence of streams and other water bodies and to provide reference to general site location (see Figure 2). The USGS topographic map indicates one stream in the southern portion of the site. The overall site generally drains east to west.
- U.S. Fish and Wildlife Service National Wetlands Inventory (NWI) map, dated July 12, 2016, was reviewed to assess the location of mapped Federal wetlands (see Figure 3). The NWI map does not indicate the presence of federal wetlands on the subject site.

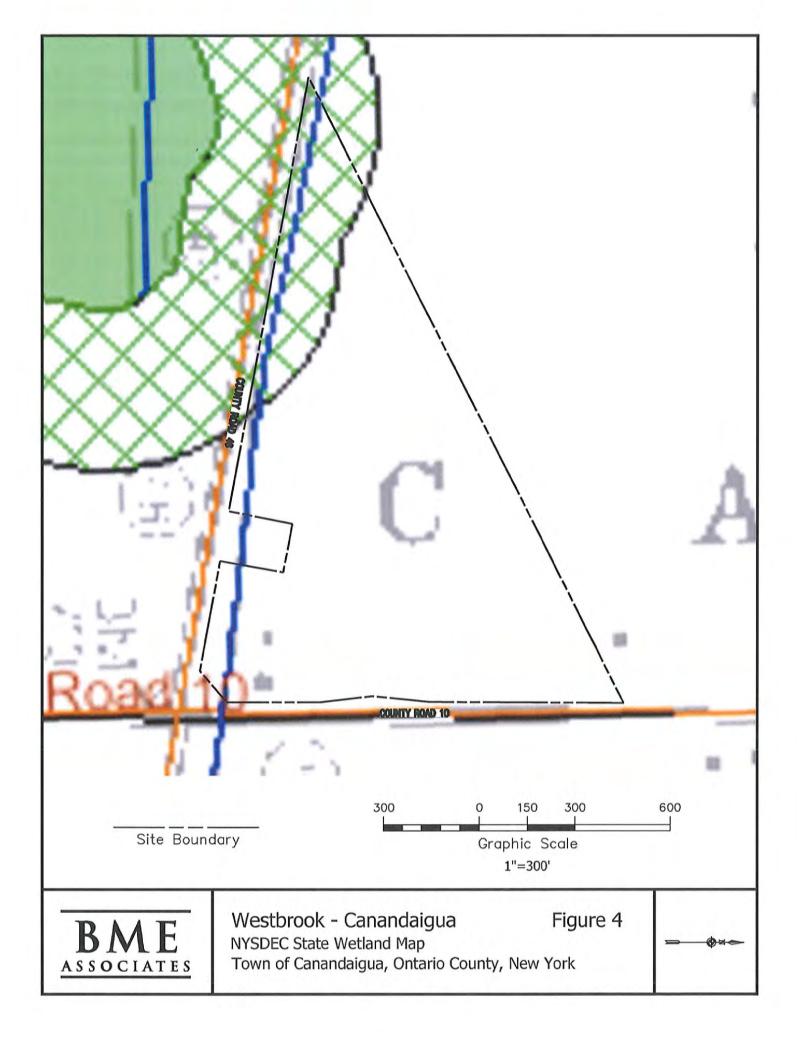
Figure 4 – NYSDEC Freshwater Wetlands Map

New York State Department of Environmental Conservation (NYSDEC) Freshwater Wetlands Map was also reviewed to determine the presence of any mapped NYSDEC wetlands on the project site (see Figure 4). The wetland map indicates a stream in t southern portion of the site and a check zone extending onto the site. It appears that on-site wetlands are more than 165 feet from any existing state wetlands and would not be subject to State jurisdiction.

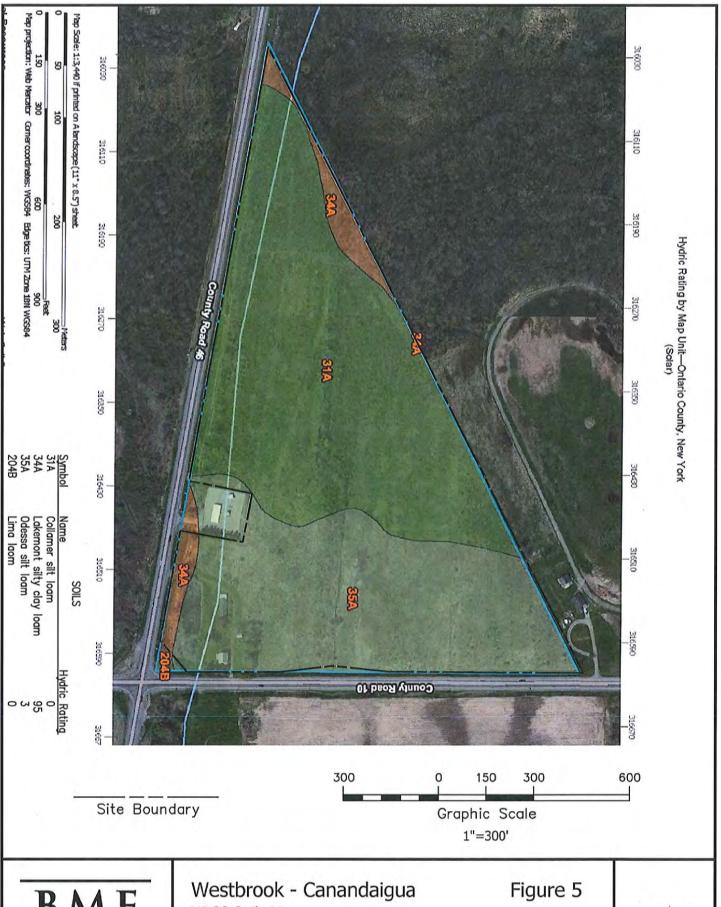
Westbrook - Canandaigua Fig NRCS Soils Map Town of Canandaigua, Ontario County, New York

- The Natural Resources Conservation Service (NRCS) Soil Survey was used to locate any hydric soils, or soils with potential hydric inclusions. The soils map indicates the presence of the following soils: Collamer silt loam with a hydric rating of 0, Lakemont silty clay loam with a hydric rating of 95, Odessa silt loam with a hydric rating of 3, and Lima loam with a hydric rating of 0 (see Figure 5).
- The Federal Emergency Management Agency Flood Map was used to determine the location of flood prone areas where wetlands may exist. The community panel number is 360598 0020 C and the effective date is April 17, 1078 with a map revision on March 3, 1997. The Flood Map shows a flood area along the tributary in the southern portion of the site (see Figure 8).

The thematic map is color coded based on the composition of hydric components. The five color classes are separated as 100 percent hydric components, 66 to 99 percent hydric components, 33 to 65 percent hydric components, 1 to 32 percent hydric components, and less than one percent hydric components.

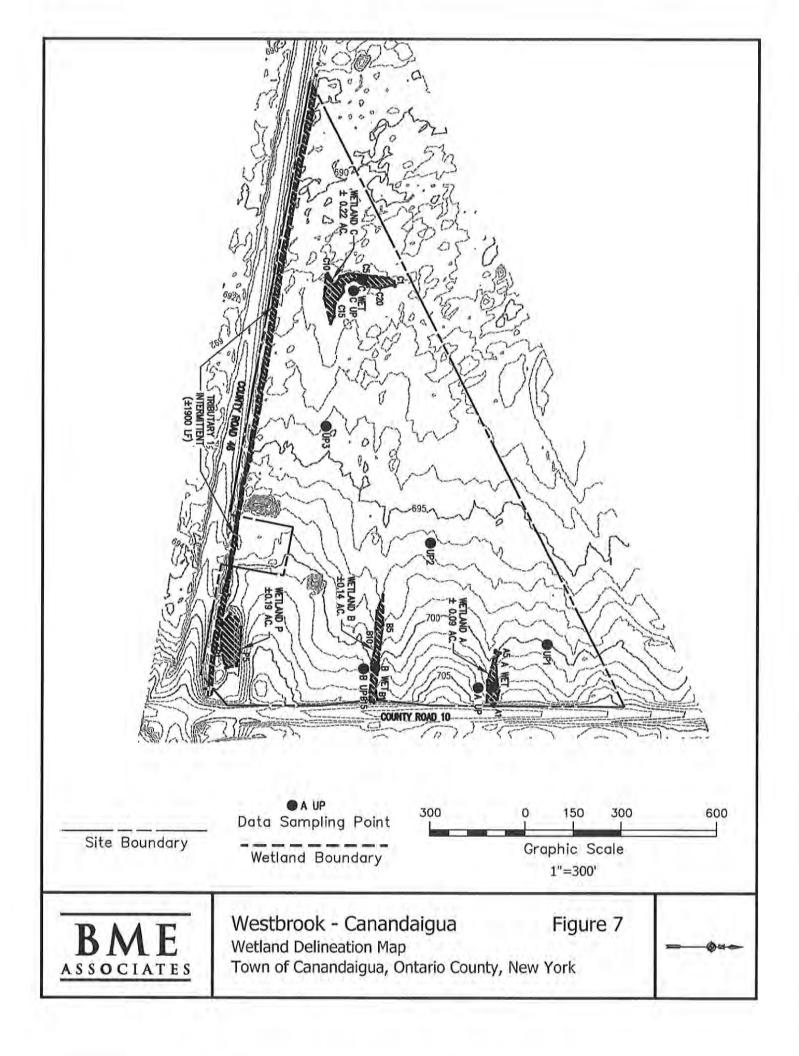
Figure 7 - Delineation Map

BME Associates delineated four (4) wetlands ("A", "B", "C" and "P"), and one (1) tributary ("1") on the subject site (Appendix A, Figure 6). BME also completed the wetland determination data forms and took photographs in July of 2016. The wetland communities that occur within the JD review area total ±0.64 acres and tributaries total ±1900 LF, and were identified and field delineated based on the presence of all three parameters (hydrology, hydric soils and hydrophytic vegetation) for federal jurisdictional wetlands. Considering available mapping and field investigations, it appears that wetlands "A", "B" and "C" lack any connection to downstream waters and may be isolated. Meanwhile, wetland "P" and the on-site tributary "1" appear to have hydrological connections to downstream waters, but final jurisdictional determination will be made by the U.S. Army Corps of Engineers. On behalf of Greg Westbrook, BME Associates requests an approved JD for the water resources described in this report.

Wetland specialists at BME Associates delineated the following features on the subject site: Four (4) wetlands: "A" (±0.09 Ac.) and "B" (±0.14 Ac.), "C" (±0.22 Ac.) and "P" (±0.19); One (1) tributary: "A" (±1900 LF)

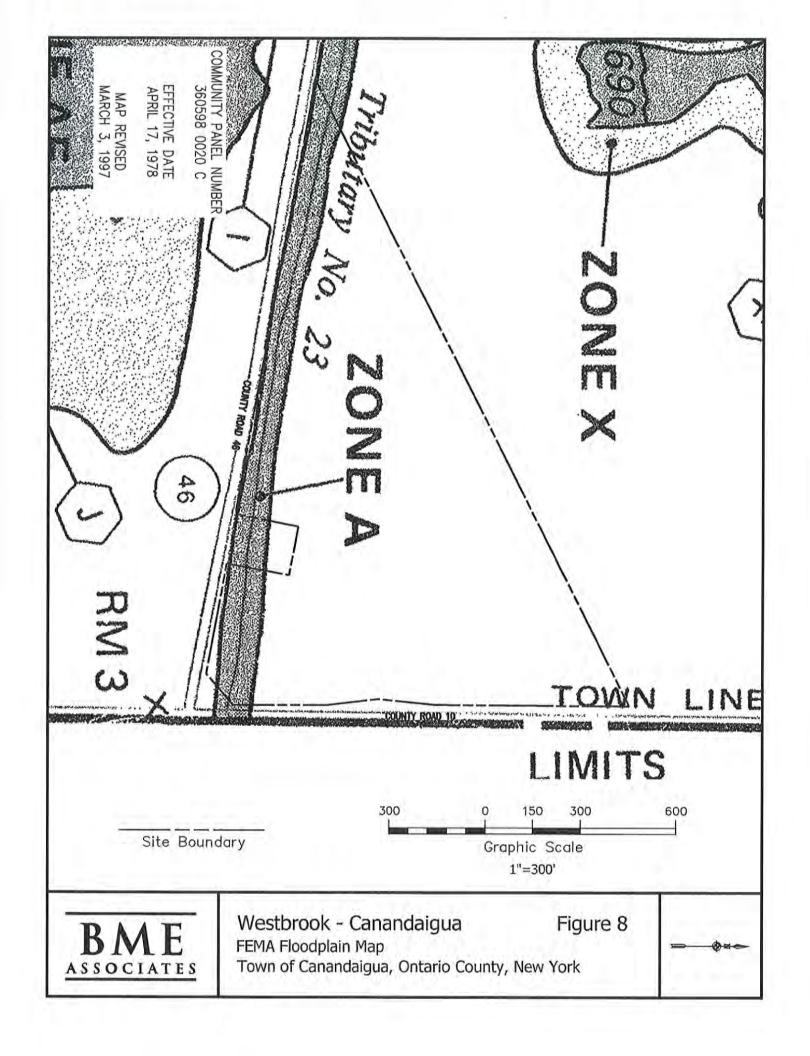
Figure 8 - FEMA Floodplain Map

<u>Tributary "1" – ± 1900 LF (INT):</u> This intermittent stream is located along the southern site boundary and flows east to west eventually discharging to the Canandaigua Outlet. The channel is approximately 10 feet wide and 1 to 2 feet deep. The stream was not flowing during site visits displaying a lack of perennial flow. Hydrological indicators such as drift lines suggest intermittent flow. This tributary is subject to a FEMA floodplain.
