WETLAND DELINEATION REPORT

**Canandaigua Shores
(3535 East Lake Road)**

**Town of Canandaigua, Ontario County
New York**

October 11, 2021

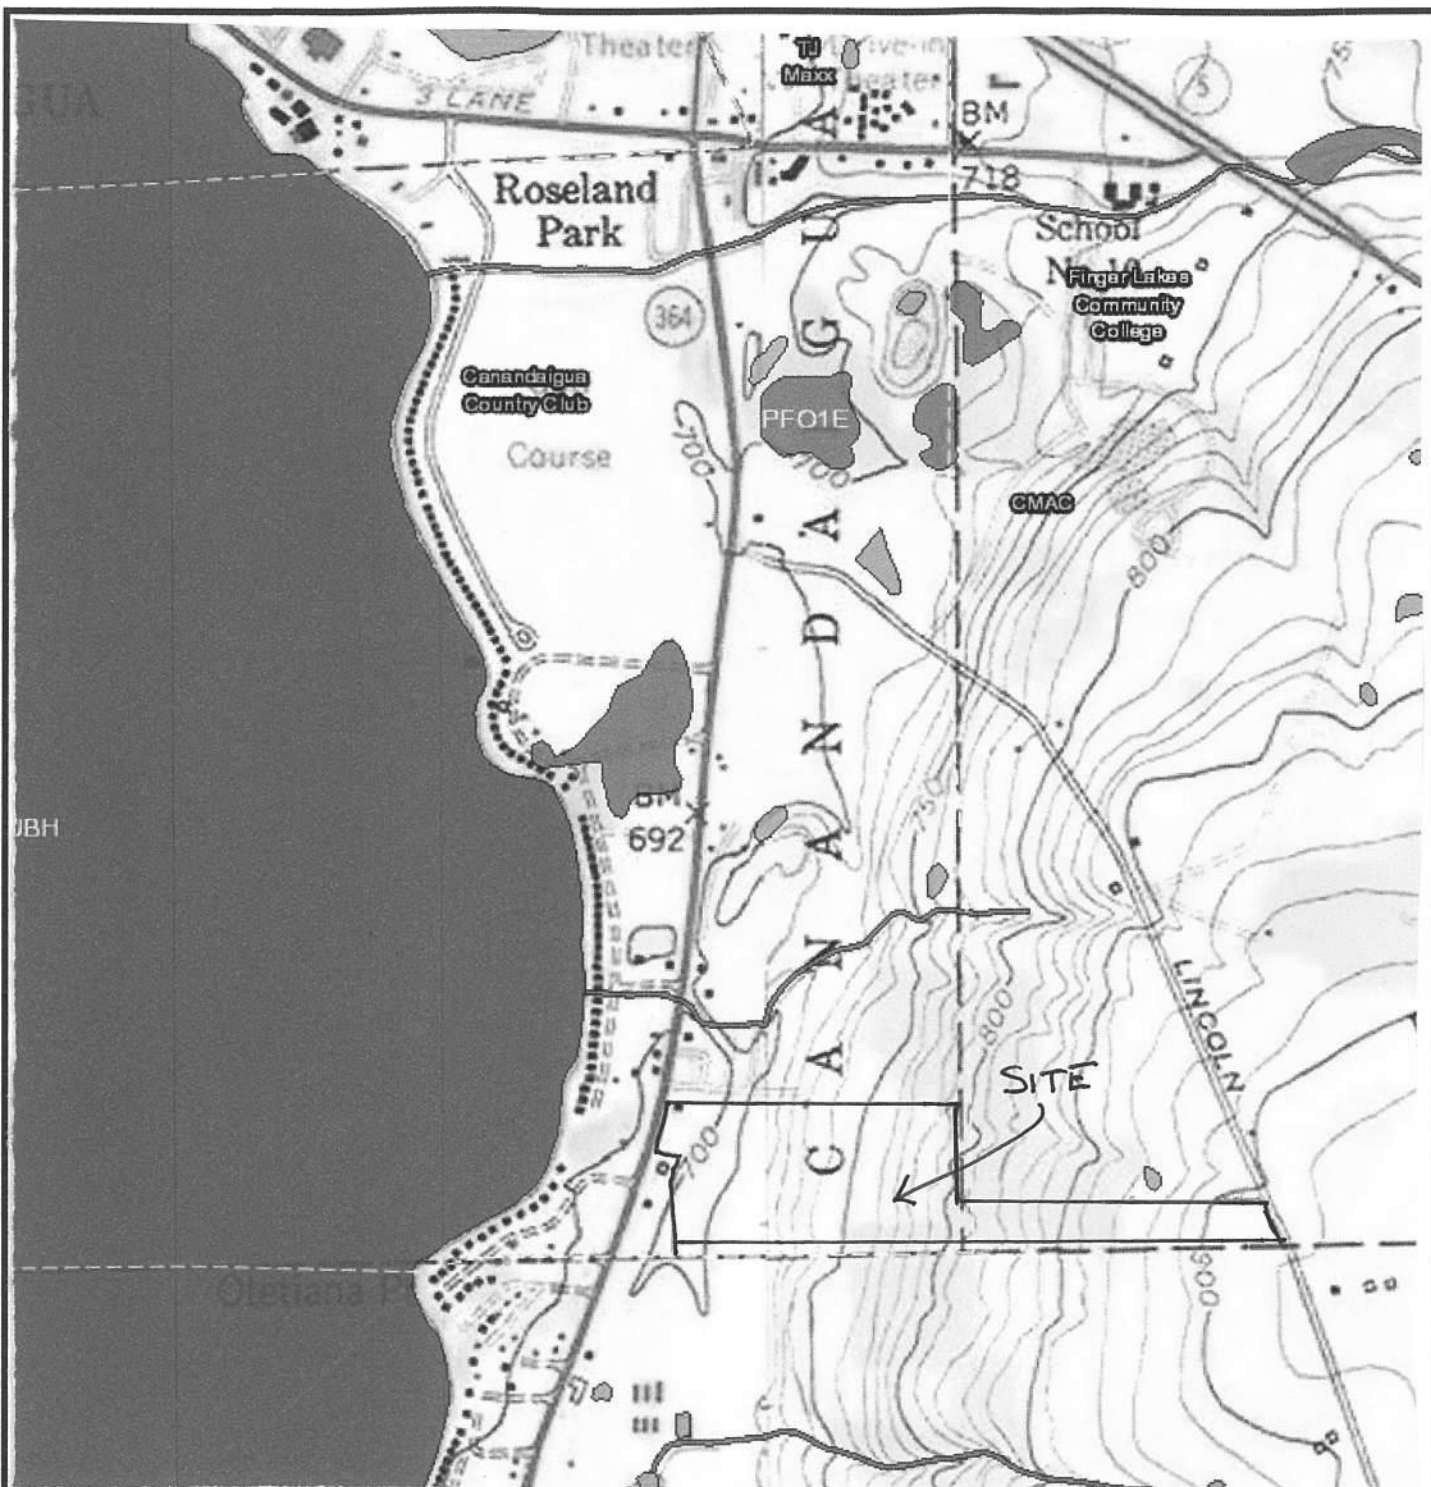
FIGURE 2. FEDERAL WETLANDS

The NWI map (Figure 2) indicates there to be no federal wetlands mapped on the project site.

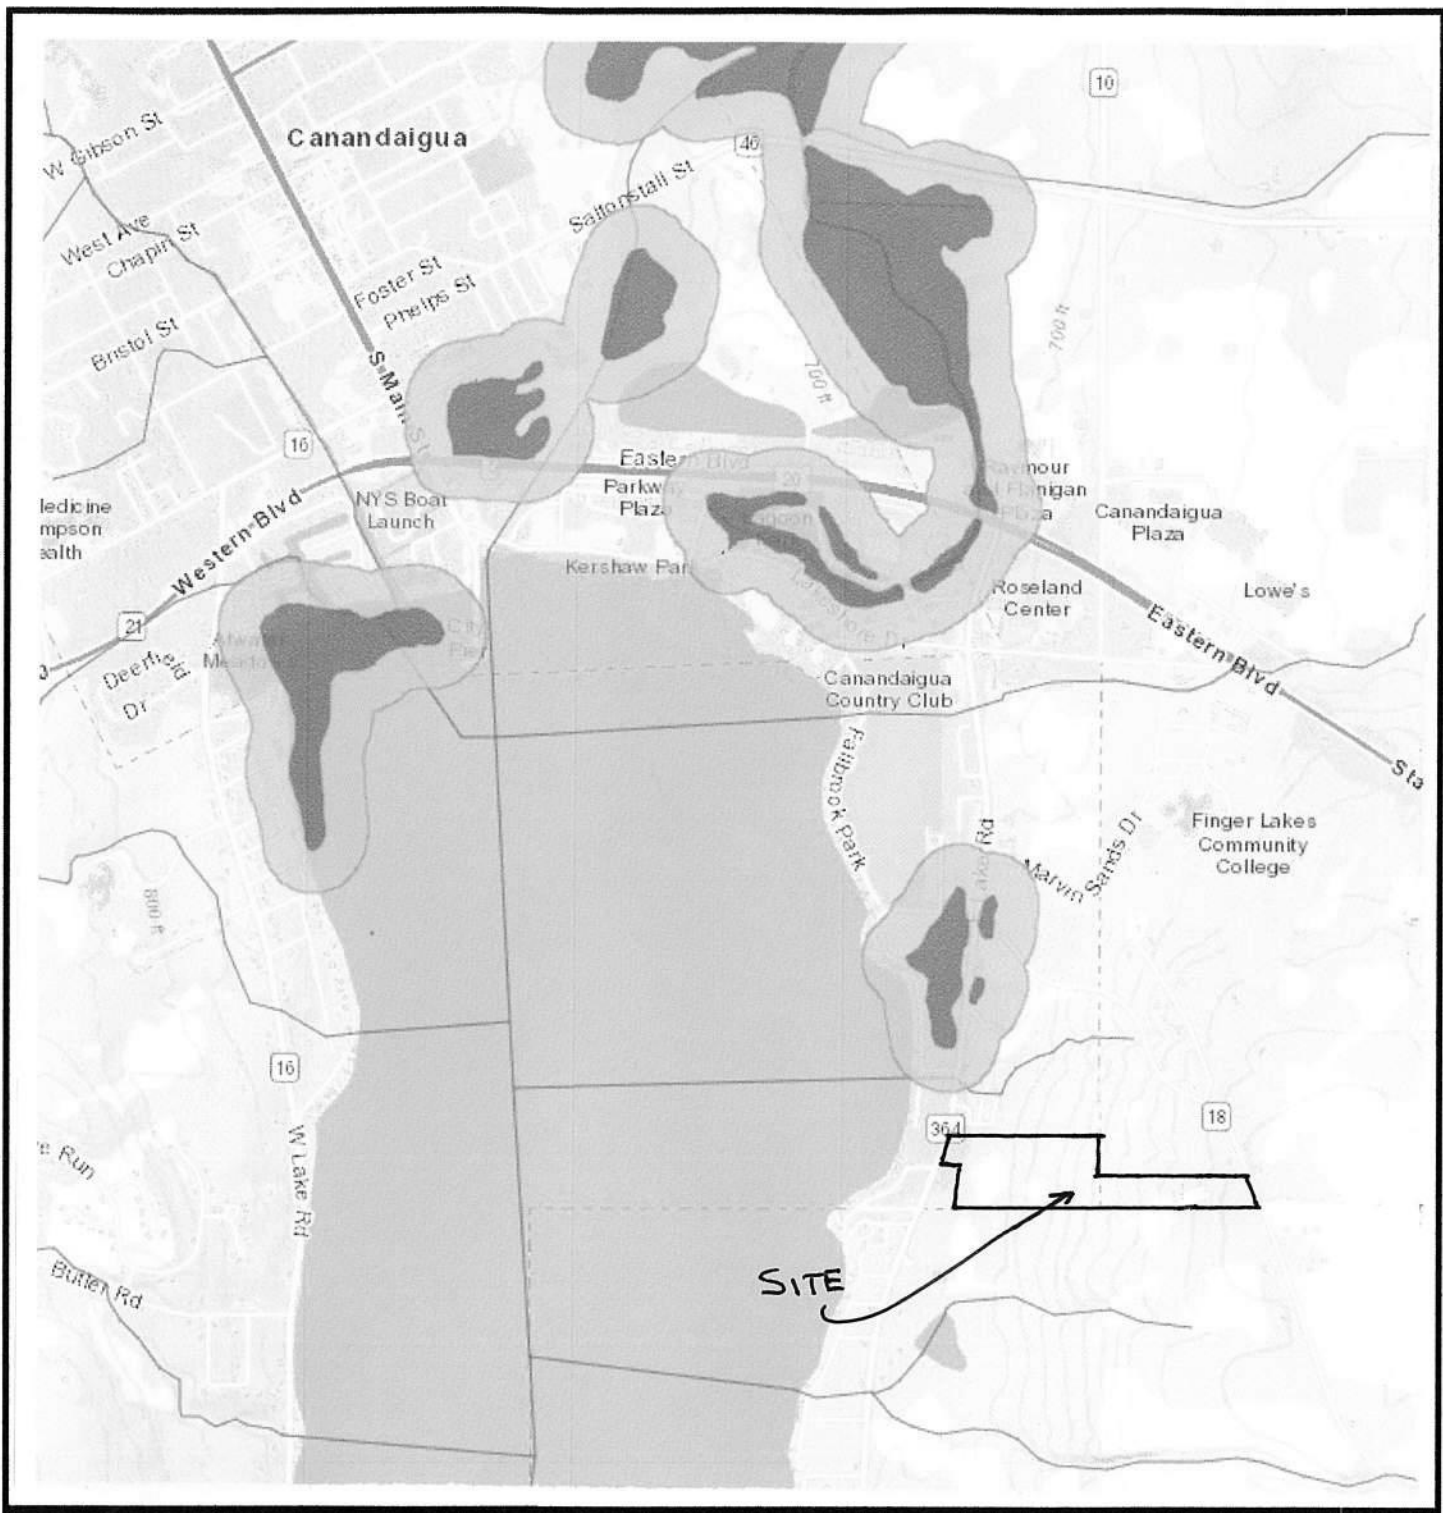
FIGURE 3. STATE WETLANDS

As shown in Figure 3, no DEC wetlands are suspected to be present on and adjacent to the site.

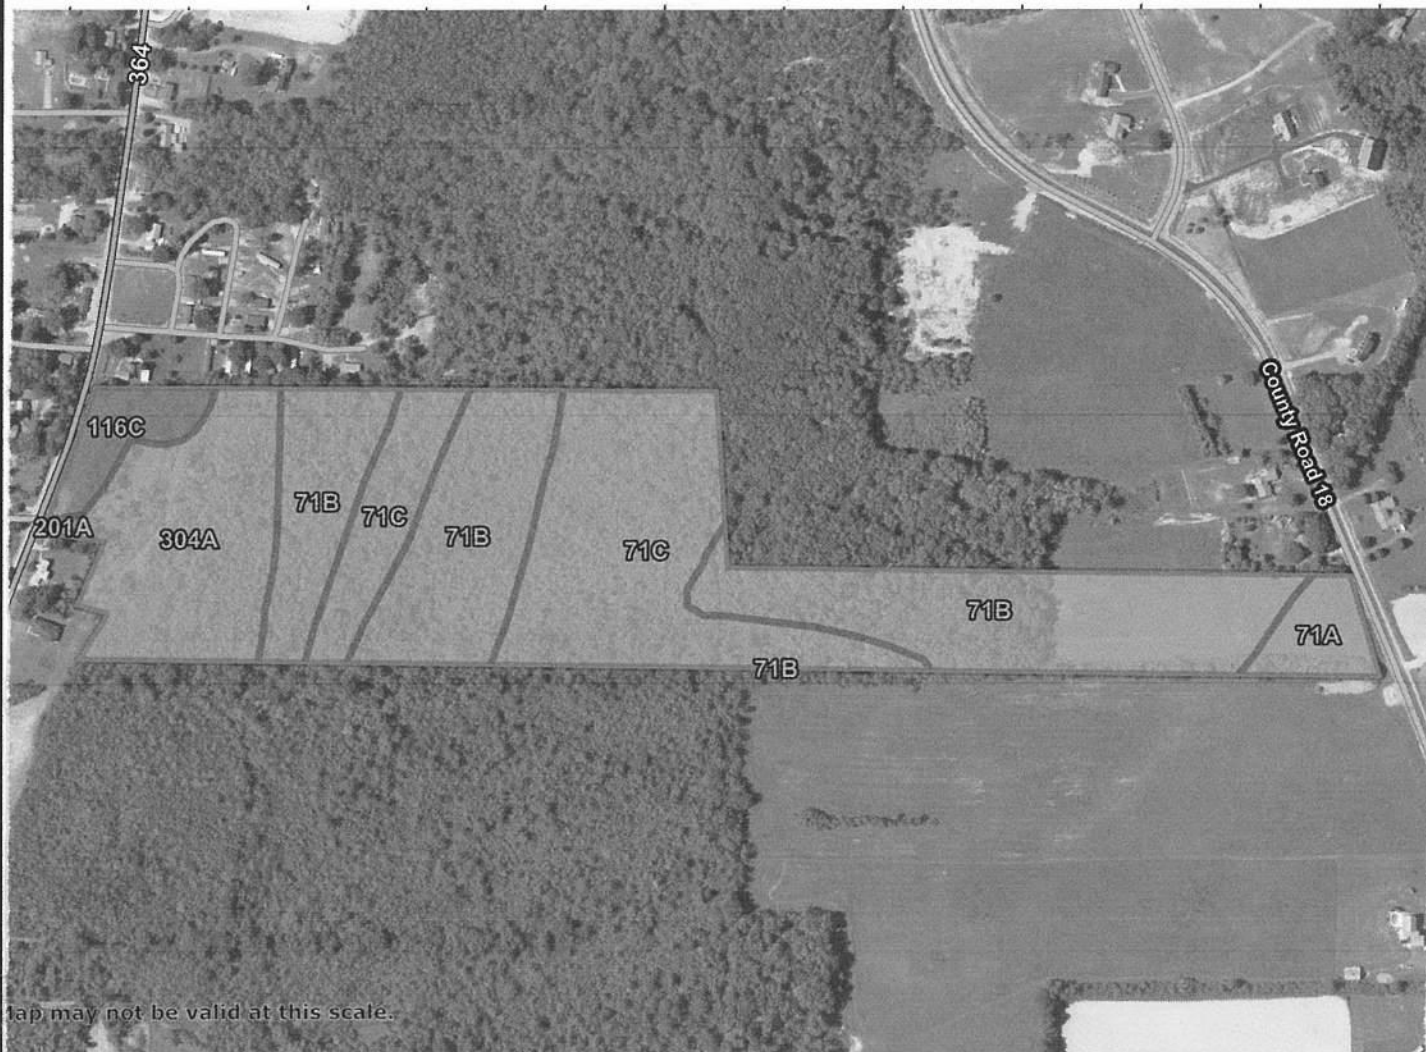
FIGURE 4. SOILS

A review of the Ontario County Soil Survey (USDA, 1958) indicates agricultural land and shrub/woodlands on the study area. The soil types are described below and shown in Figure 4.

- 71A – Darien silt loam, 0 to 3 percent slopes, somewhat poorly drained soils. The Darien soil series is derived from loamy till predominantly from calcareous gray shale. Soil occupies approximately 3.8 percent of the study area.

- 302A – Kendaia loam, 0 to 3 percent slopes, somewhat poorly drained soils. Calcareous loamy till derived from limestone, sandstone, and shale. Soil occupies approximately 17.7 percent of the study area.

The USDA Natural Resource Conservation Service (USDA SCS, 1989) has determined that there no hydric soils mapped on the study area. The Darien and Kendaia soil series have the potential for hydric soil inclusions.

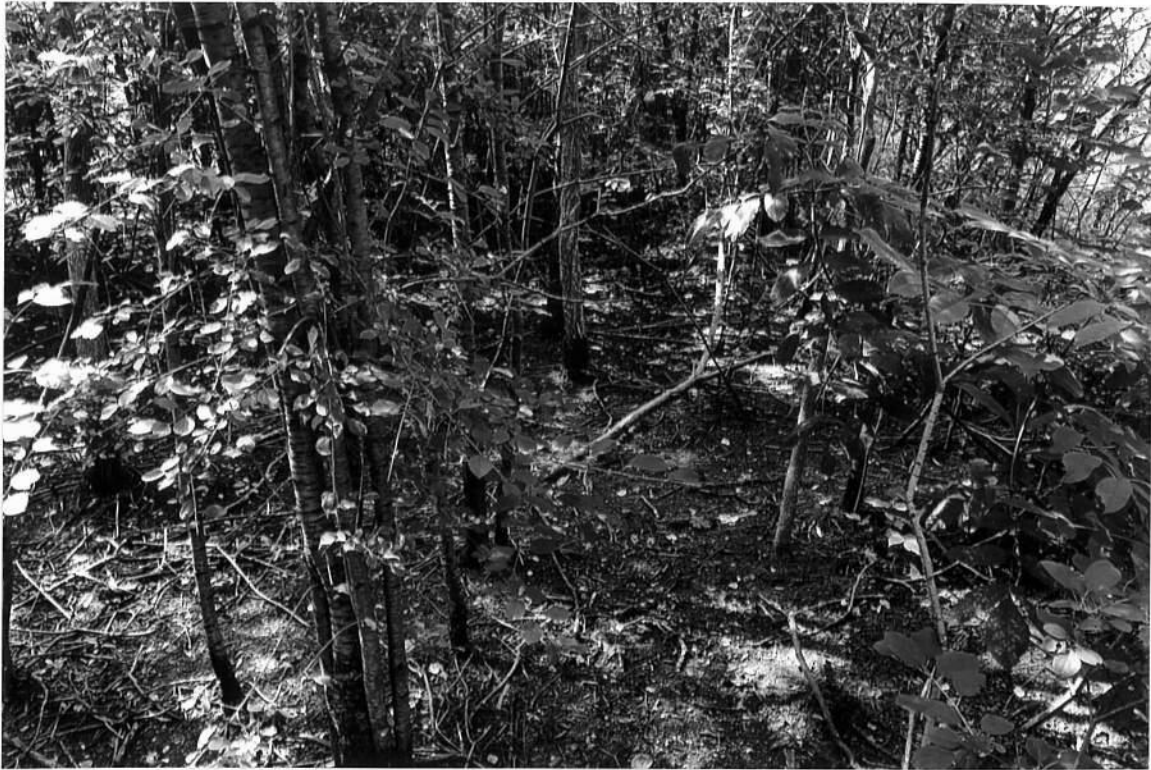
Wetland A is an 0.081 acre seasonally flooded, depressional, late scrub-shrub wetland (Photo 1) that has a small drainage outlet (one foot wide and 18 inches deep), that appears to have been excavated through 20-feet of uplands before discharging into an adjacent intermittent drainage. Dominant vegetation includes green ash (*Fraxinus pensylvanica*-FACW) saplings and trees, and common buckthorn (*Rhamnus cathartica*-FAC) shrubs. Underlying hydric soils have a redox dark surface matrix color of 10YR3/1 (very dark gray) to 10YR3/2 (very dark grayish brown) with high chroma mottles in the A horizon, and a B horizon of 10YR4/1 (dark gray) with high chroma mottles. Indicators of wetland hydrology include water marks, sparsely vegetated concave surface, and water-stained leaves.

PHOTO 1. View of scrub-shrub Wetland A.

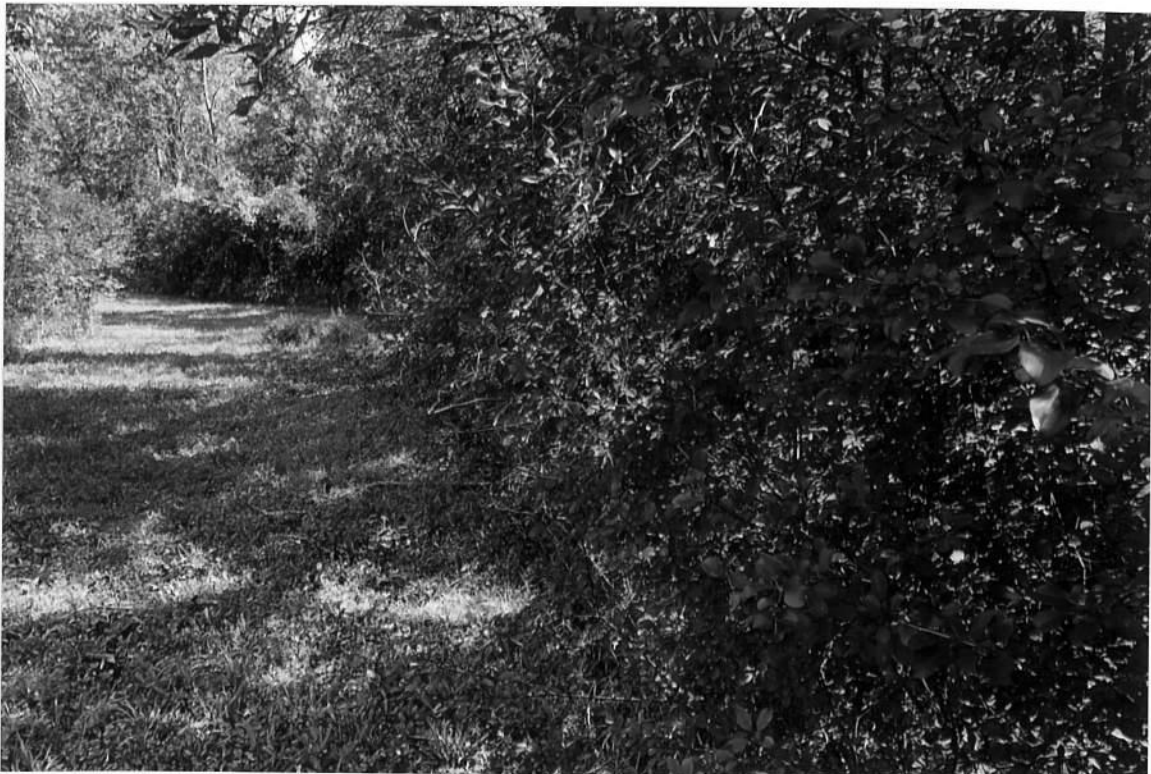
Lands next to Wetland A are a successional scrub-shrub/woods and a mowed, widened old-field trail. (Photo 2). Characteristic vegetation includes cherry (*Prunus* spp.-FACU) trees, common buckthorn, multiflora rose (*Rosa multiflora*-FACU), and black raspberry (*Rubus occidentalis*-UPL) shrubs, with white avens (*Geum canadense*-FACU), wild madder (*Galium mollugo*-FACU), birdsfoot trefoil (*Lotus corniculatus*-FACU), speckled aster (*Aster simplex*-FACW), heal-all (*Prunella vulgaris*-FACU), Canada goldenrod (*Solidago canadensis*-FACU), common dandelion (*Taraxacum officinale*-FACU), and poison ivy (*Toxicodendron radicans*-FAC) on the ground plain, and summer grape (*Vitis aestivalis*-FACU) vines. Underlying non-hydric soils have a matrix color of 10YR3/2 to 10YR4/2 (dark grayish brown) with no mottles in the A horizon, and 10YR3/2 to 10YR4/2 with no mottles in the B horizon. Hydrologic characters are absent.

PHOTO 2. Representative view of site uplands (including mowed trails) along the west side of Wetland A.

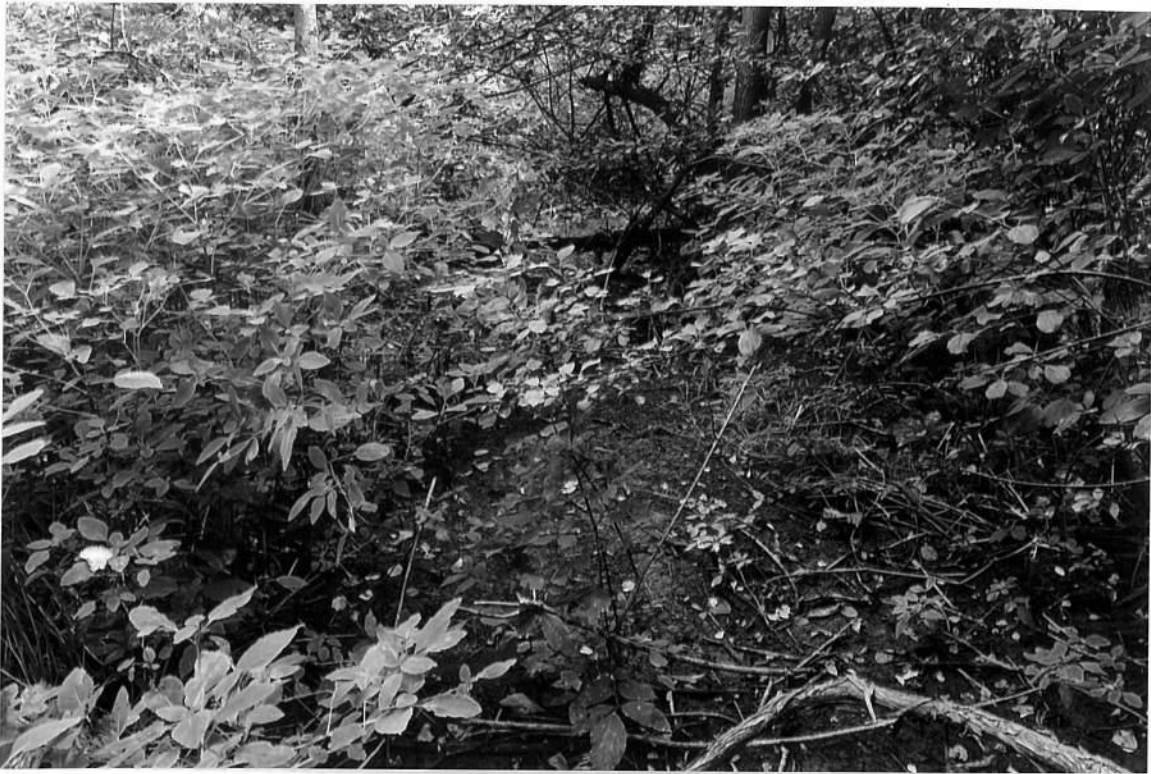
An intermittent stream (839 linear feet; 0.166 acres) was excavated in the past from north to south to carry drainage from an eastern flowing drainage off the steep eastern slope across the study area to end up as a further drainage off site southwesterly to Canandaigua Lake. (Photo 3). This on-site stream (839 linear feet; 0.166 acres) is approximately 8 to 10 feet wide, and is 18-inches to 3 feet below grade, and has a silt bed. At the time of our data collection the drainage contained no water. Characteristic vegetation includes silky dogwood (*Cornus amomum*-FACW), subcordate water plantain (*Alisma subcordatum*-OBL), pale touch-me-not (*Impatiens pallida*-FACW), European bugleweed (*Lycopus europaeus*-OBL), and speckled aster. Underlying hydric soils have a depleted matrix color of 10YR3/1 with high chroma mottles in the A horizon, and 10YR4/1 with high chroma mottles in the B horizon. Hydrologic characters include water marks, sediment deposits, inundation visible on aerial imagery, and drainage pattern.

PHOTO 3. View of on-site channelized, intermittent drainage crossing the sites west end from north to south.

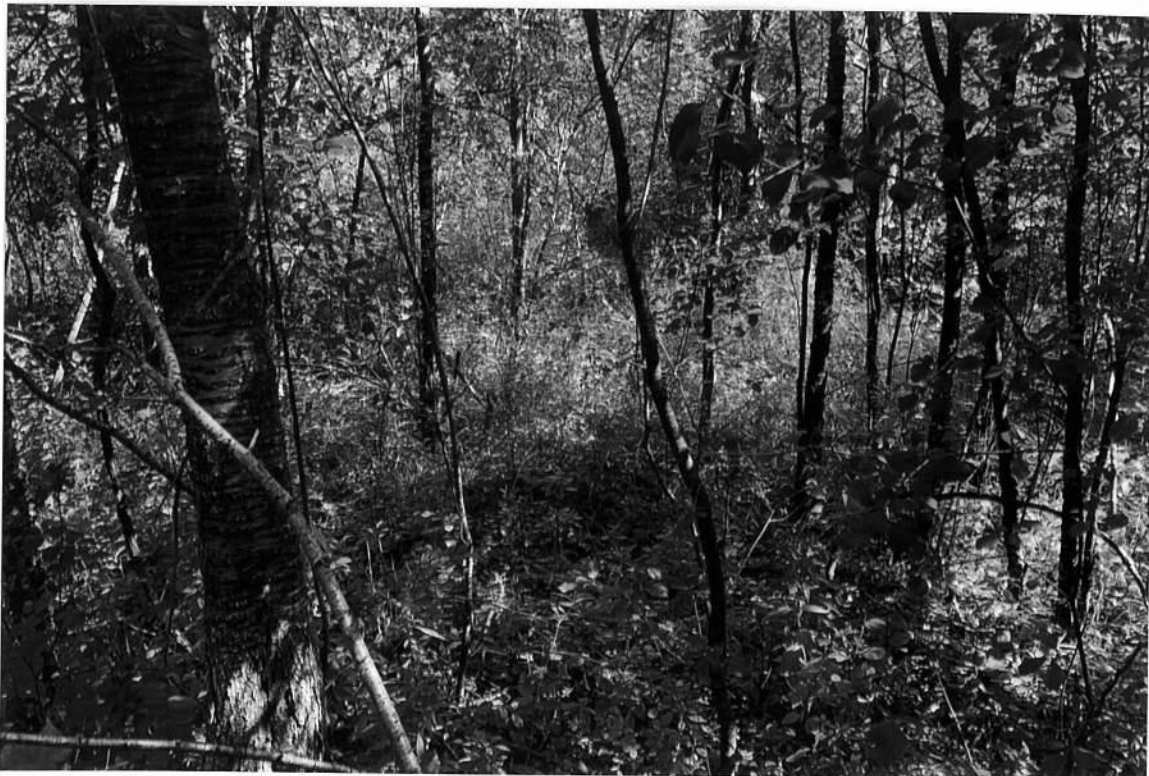
Lands adjacent to this intermittent drainage are late successional scrub-shrub/woods. (Photo 4). Characteristic vegetation includes quaking aspen (*Populus tremula*-FACU), green ash, and box elder (*Acer negundo*-FAC) trees, common buckthorn, tartarian honeysuckle (*Lonicera tatarica*-FACU), multiflora rose, and gray dogwood (*Cornus racemosa*-FAC) shrubs; with garlic mustard (*Alliaria petiolata*-FACU), speckled aster, white avens, heal-all, pale touch-me-not, tall hairy groove-bur (*Agrimonia gryposepala*-FAC), small flower groove-bur (*A. parviflora*-FACW), white vervain (*Verbena urticifolia*-FACU), summer grape, Virginia creeper (*Parthenocissus quinquefolia*-FACU), and poison ivy on the ground plain. Underlying non-hydric soils have a matrix color of 10YR3/2 with no mottles in the A horizon and 10YR4/2 to 10YR4/3 (brown) with no mottles in the B horizon. There are no indicators of wetland hydrology in the adjacent uplands.

PHOTO 4. Representative view of successional shrub/woodlot uplands characterizing the western portion of the study area.

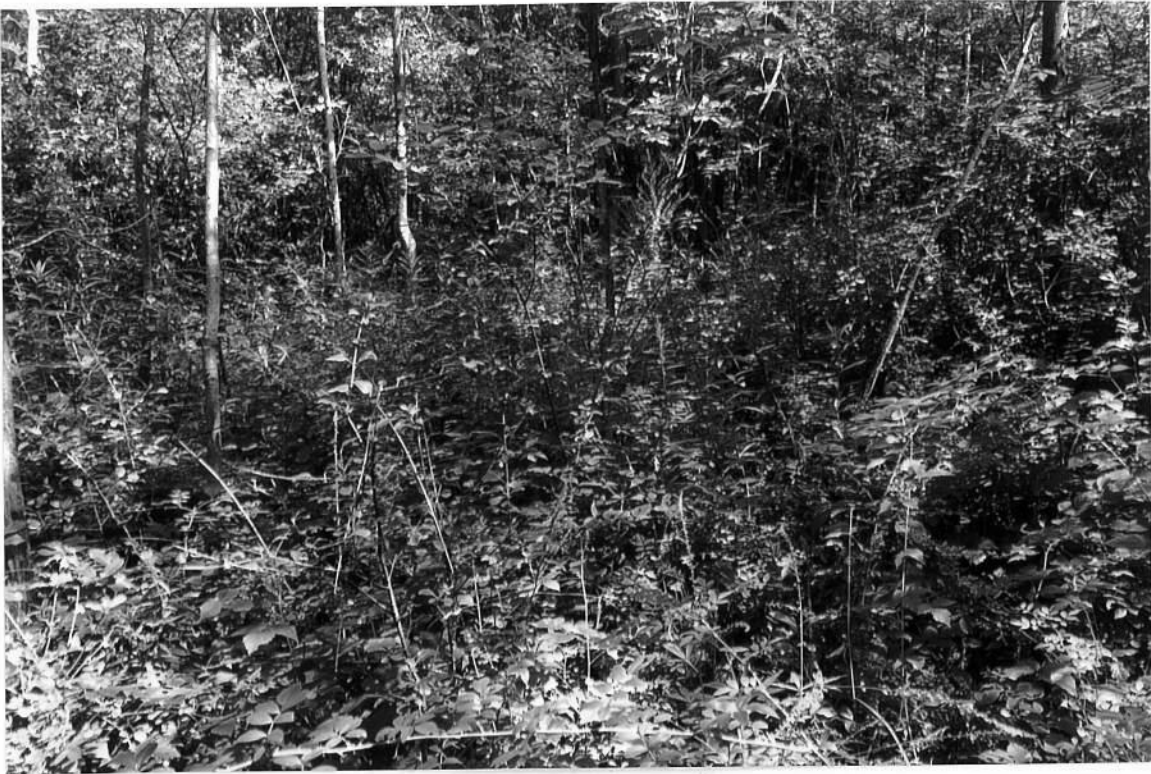
PHOTO 5. View of rising site uplands characterizing the south-central portion of the project at Data Point 5U.

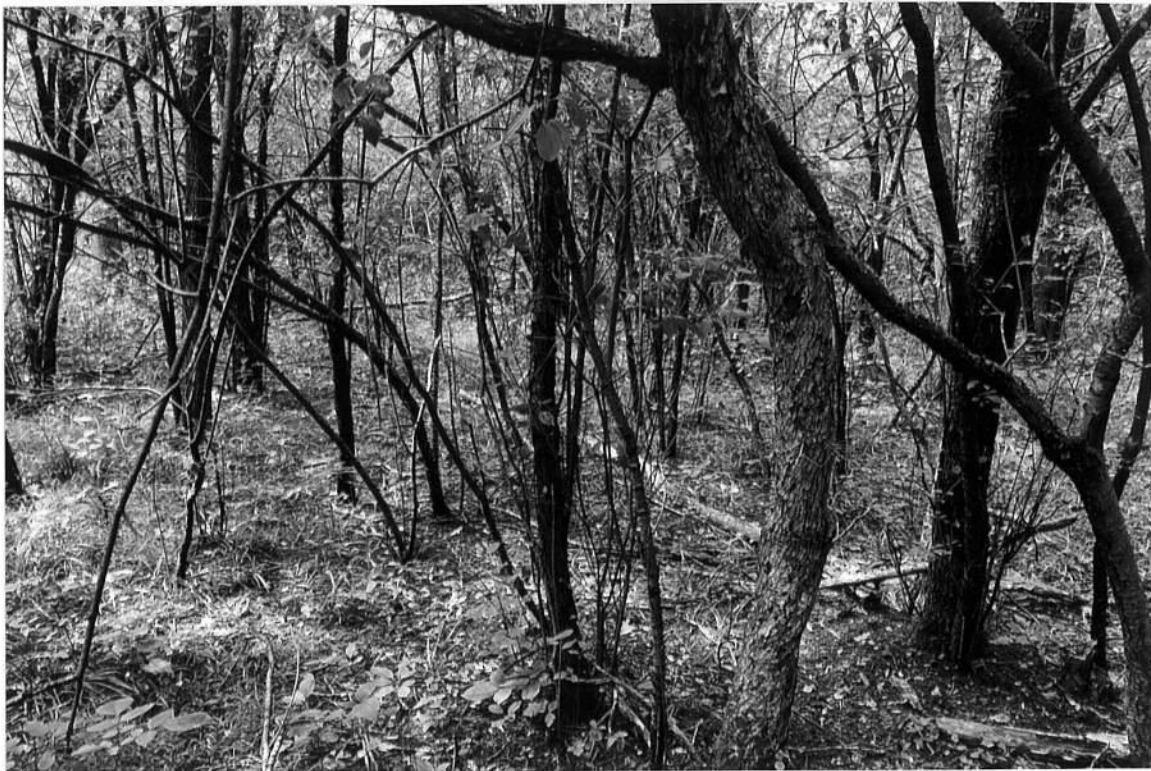
PHOTO 6. Representative view of site uplands in the north-central portion of the project site at Data Point 6U.

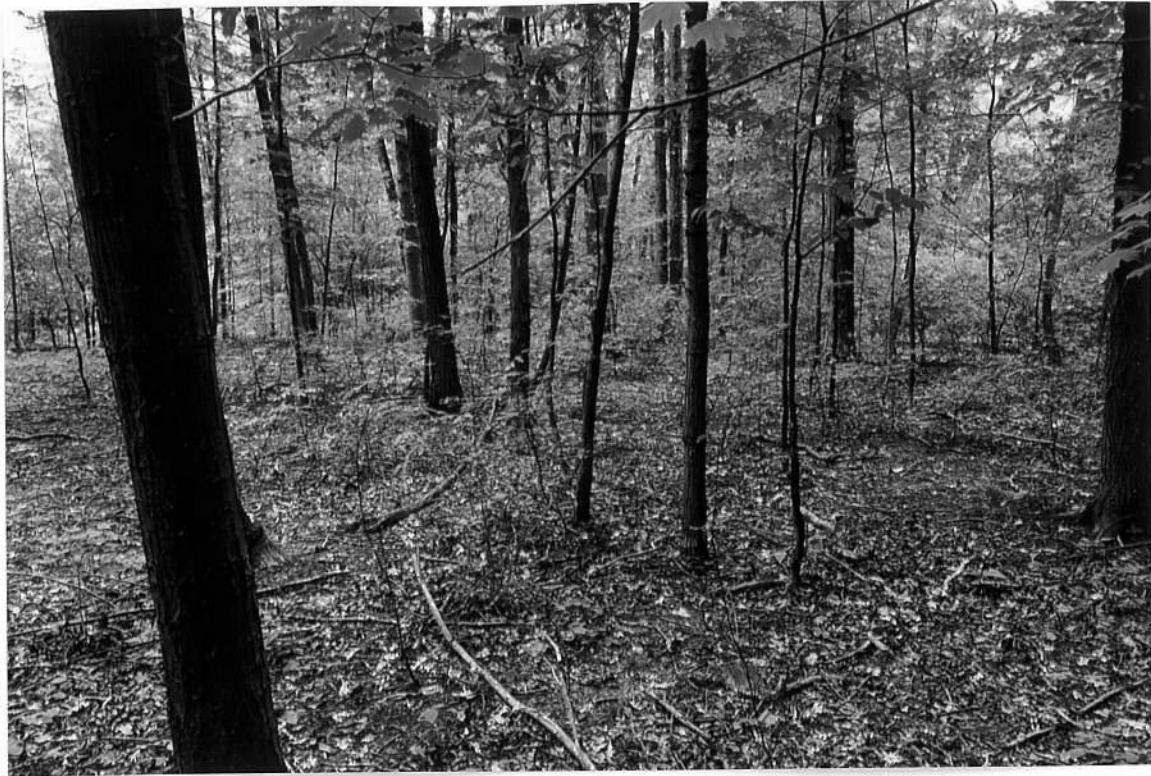
Farther up the slope to the east is characterized as a successional forest (Photo 7) dominated by white oak (*Quercus alba*-FACU), shagbark hickory (*Carya ovata*-FACU), beech (*Fagus grandifolia*-FACU), sugar maple (*Acer saccharum*-FACU), eastern hop-hornbeam (*Ostrya virginiana*-FACU), American elm (*Ulmus americana*-FACW), and Northern prickly ash (*Xanthoxylum americanum*-UPL) saplings and trees. Underlying non-hydric soils have a matrix color of 10YR6/3 (pale brown) with no mottles in both the A and B horizons. Hydrologic characters are absent.

PHOTO 7. View of successional forest uplands at Data Point 8U.

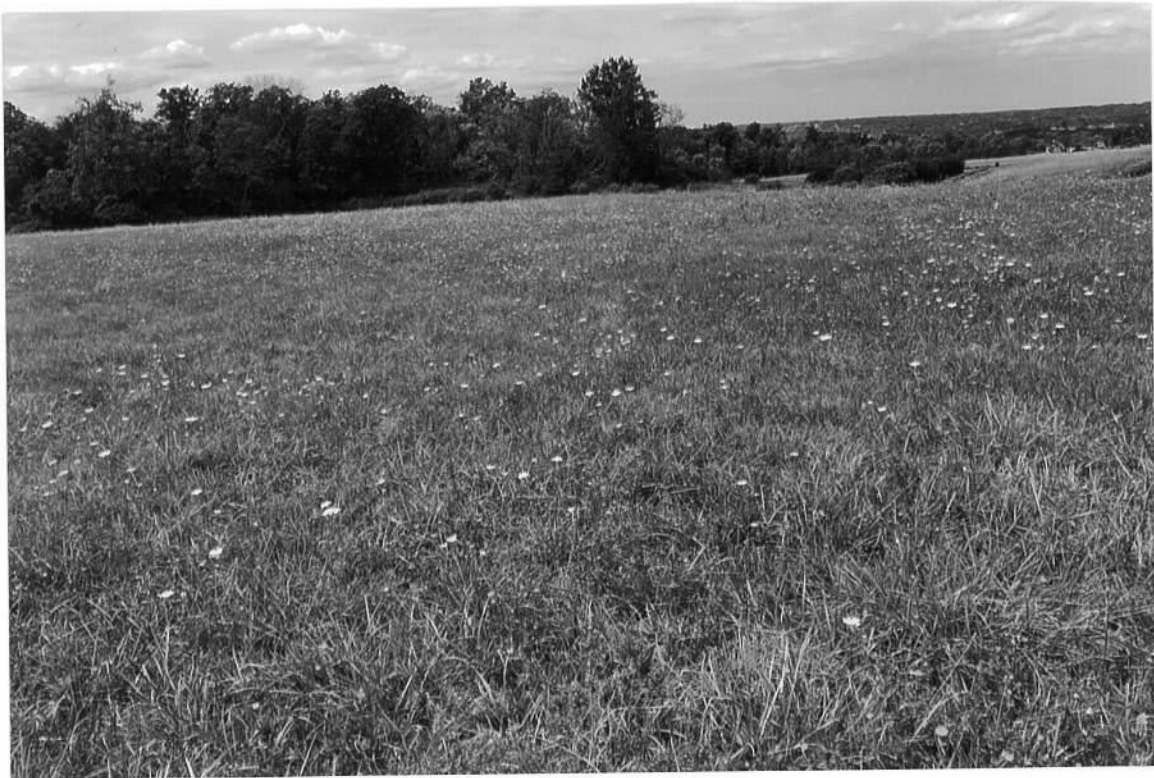
The last area was the successional old-hay field in the long narrow area to the east and that fronts on Lincoln Hill Road. (Photo 8). Characteristic herbaceous vegetation includes red clover (*Trifolium pratense*-FACU), wild madder, common dandelion, wild carrot (*Daucus carota*-UPL), common hawk weed (*Hieracium vulgatum*-UPL), English plantain (*Plantago lanceolata*-UPL), and upland grasses. Underlying non-hydric soils have a matrix color of 10YR4/3 without mottles in both the A and B horizons. Hydrologic characters are absent.

PHOTO 8. Old-hay field uplands representing the sites east end.
