7/20/2021

I am assisting Mr. Brad Fuster in resolving the issues with respect to the removal of 14 dead or dying ash trees in a deed-restricted area on his property located at 3663 Summit Vw, Canandaigua, NY 14424.

Trunk sizes and stump heights of the 14 removed ash trees

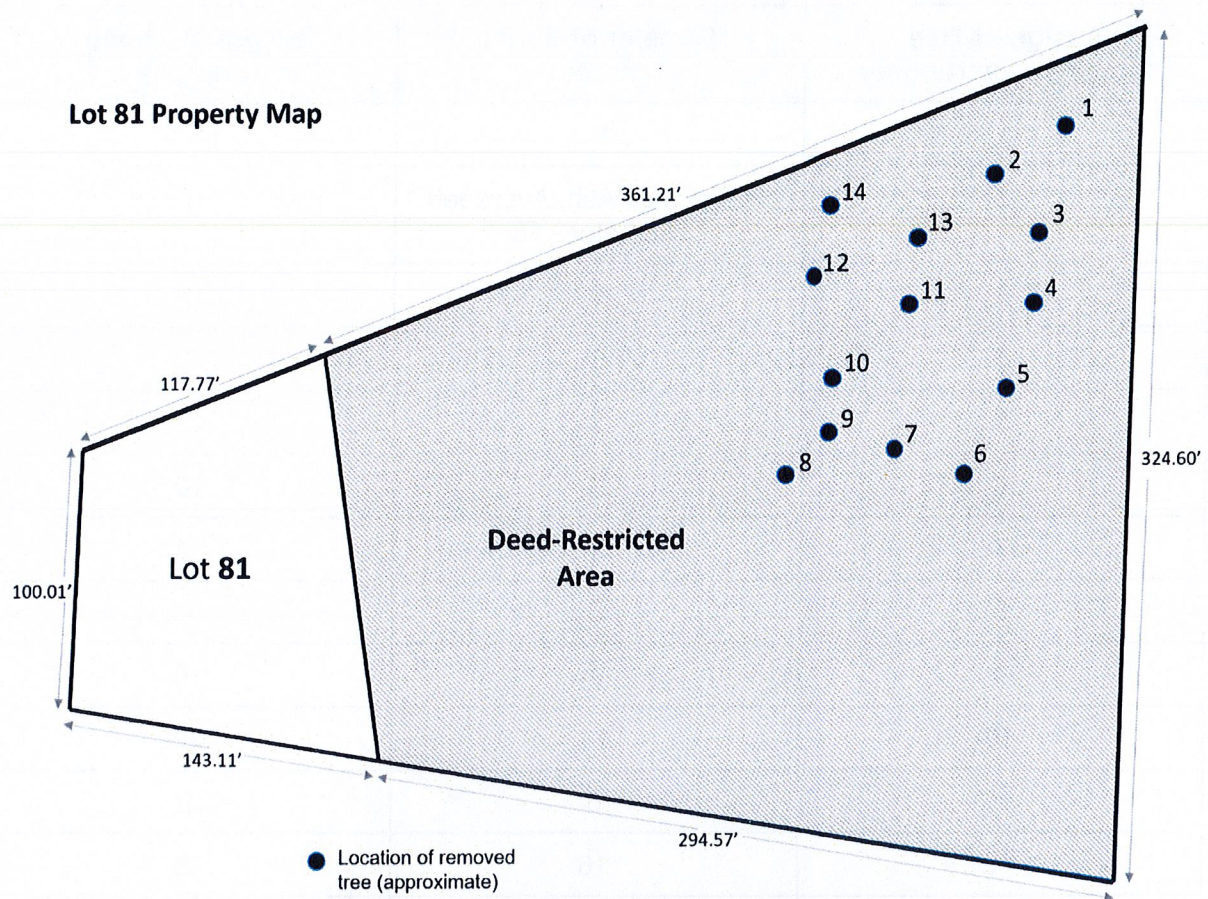
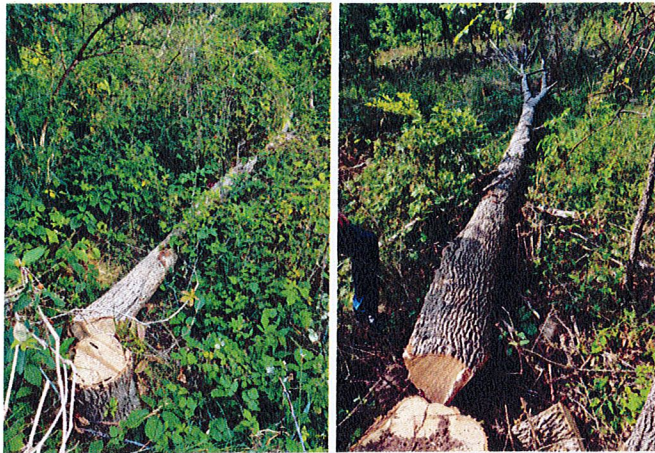
The plot map below denotes the stump locations of the 14 EAB infested/dead ash trees that were removed.

Tree 1 and Tree 12: Had extensive evidence blanding and EAB damage on the bark. These trees were not going to survive and were hazardous if left standing.
