4788 COUNTY RD. 16 CANANDAIGUA, N.Y.

2 MINK BARN- RENDERED VIEWS

MINK BARN-NORTH WALL: EXT./INT. ELEVATIONS  
SCALE: 1/8" = 1' 0"

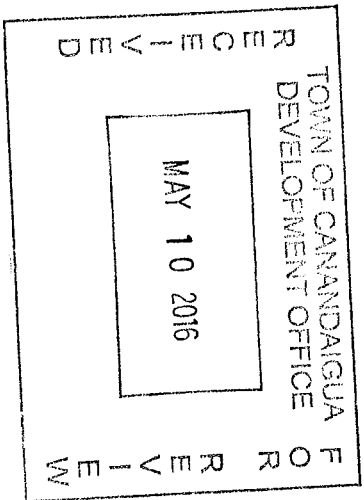
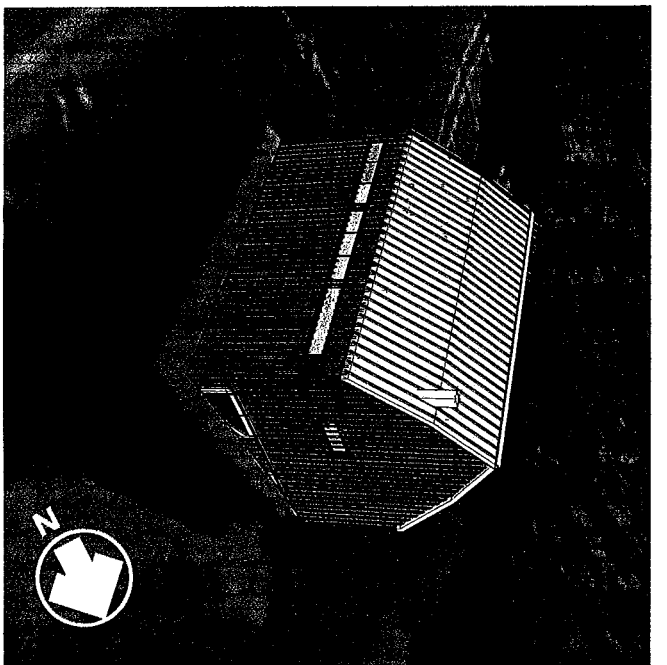
NOTE: EXIST. GRADING TO BE MODIFIED AND SUIT REMODEL.

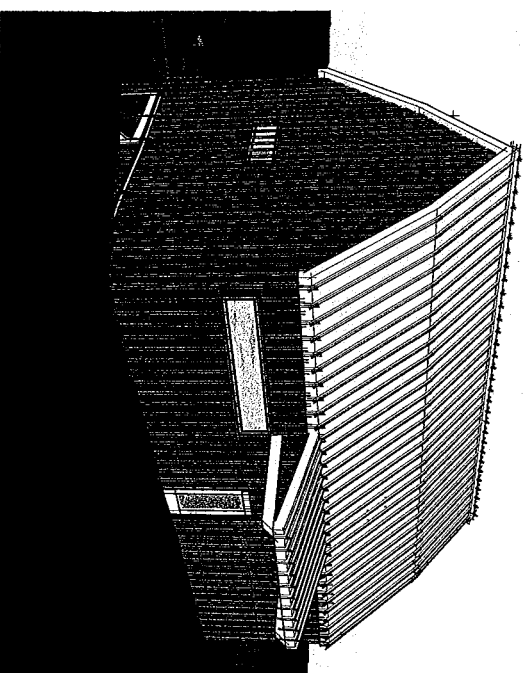
ENTRY WALL/ EAST WALL.

STANDING SEAM ROOFING. MATERIAL TYPE: TBD

EXTERIOR TREATMENT: 4/4" HARDIE BOARD  
W/ 1 X 3 HARDIE TRIM VERT. BATTEN BOARDS.  
PAINTED FINISH.

CLEAR STORY  
WINDOWS

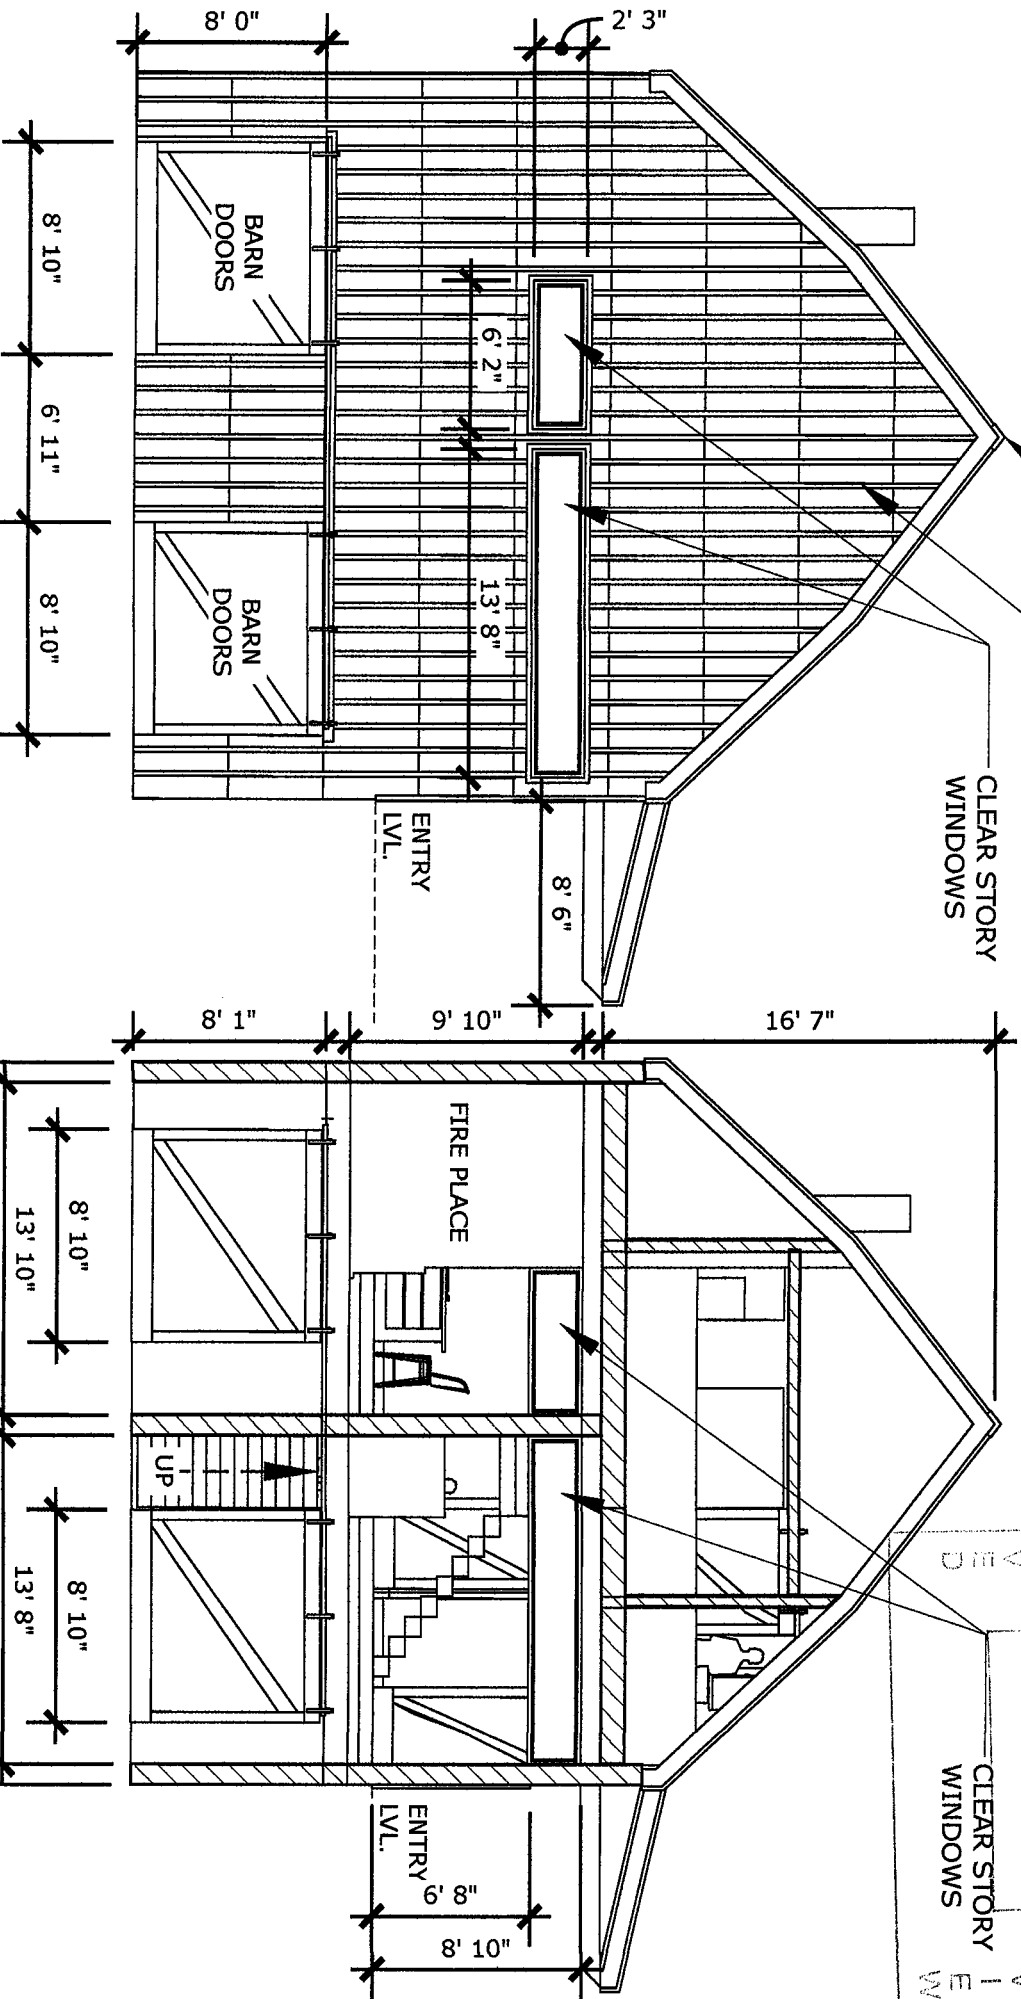
A1

EXIST. WOOD BEAMS/ FRAMING

STANDING SEAM ROOFING. MATERIAL TYPE: TBD

CLEAR STORY  
WINDOWS

EXTERIOR TREATMENT: 4/4" HARDIE BOARD  
W/ 1 X 3 HARDIE TRIM VERT. BATTEN BOARDS.  
PAINTED FINISH.

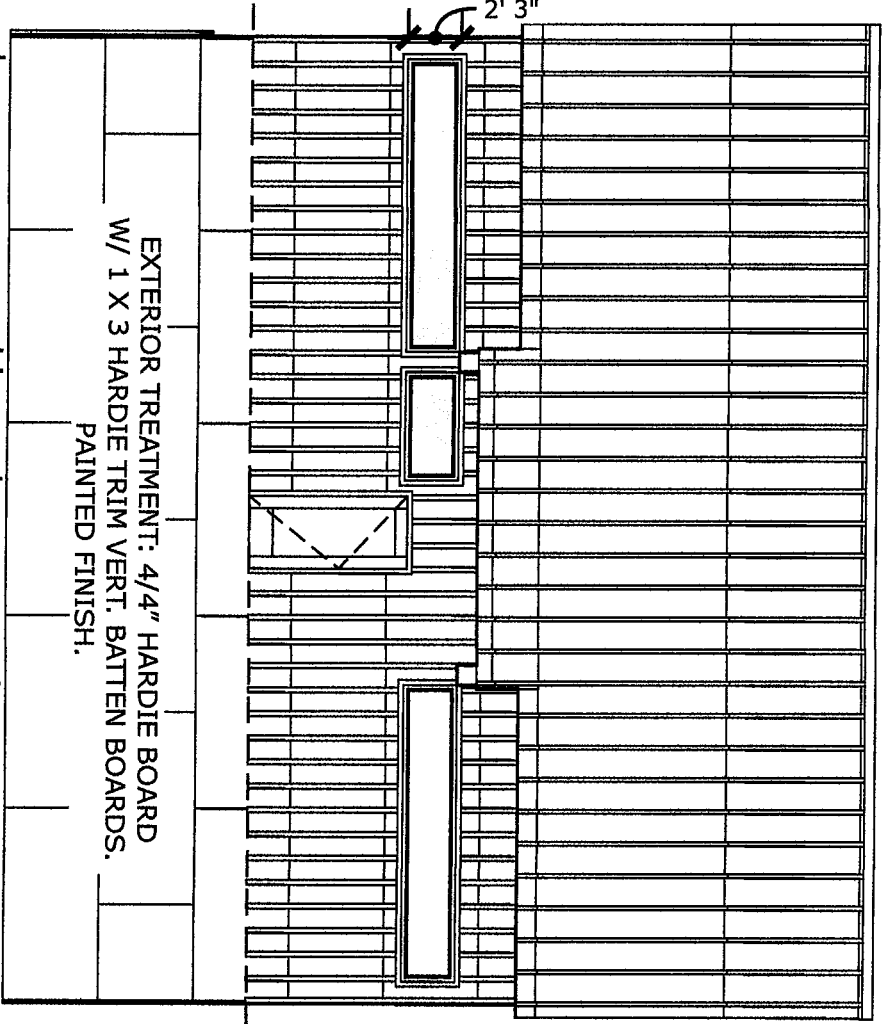
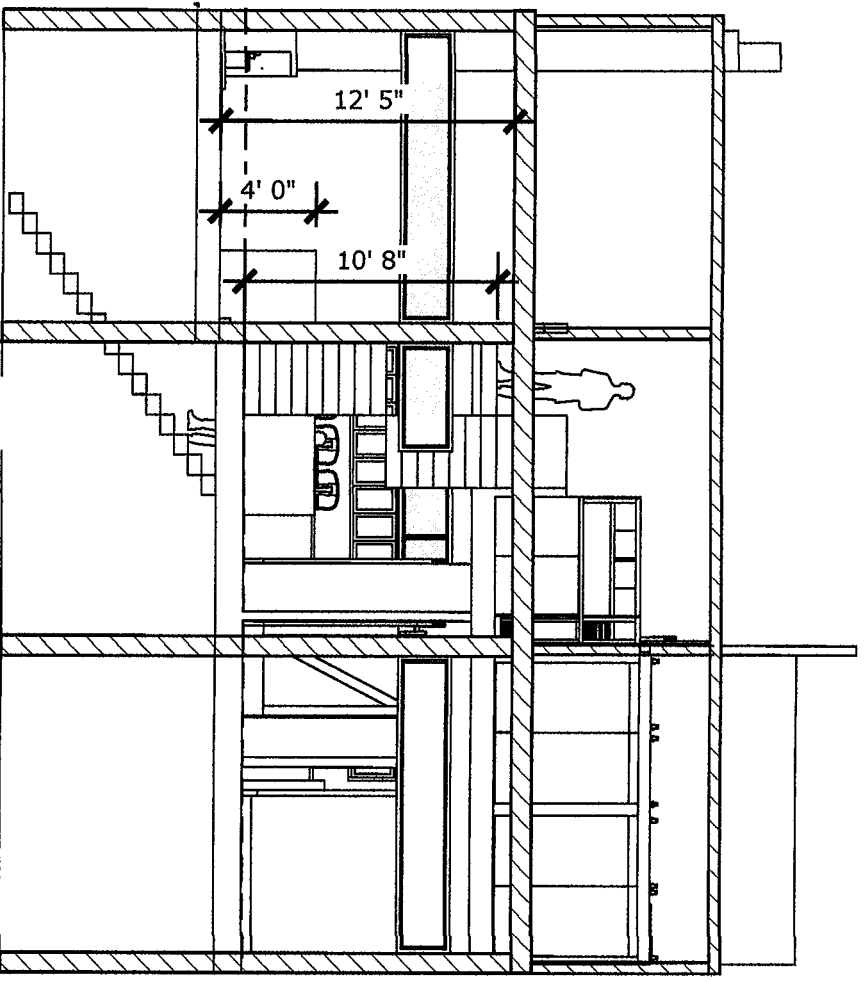
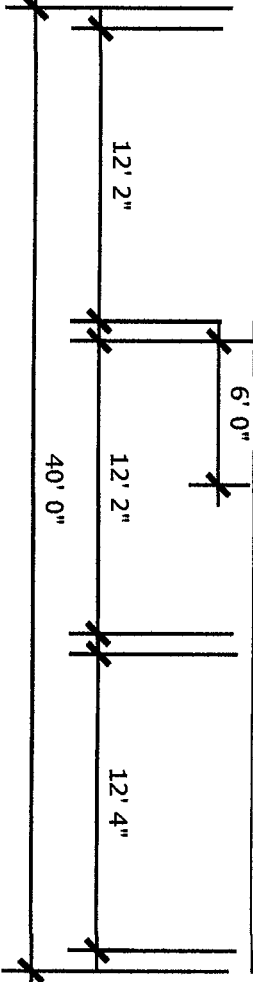
A2

EXIST. WOOD BEAMS/ FRAMING

MINK BARN-WEST WALL: EXT./ INT. ELEVATIONS

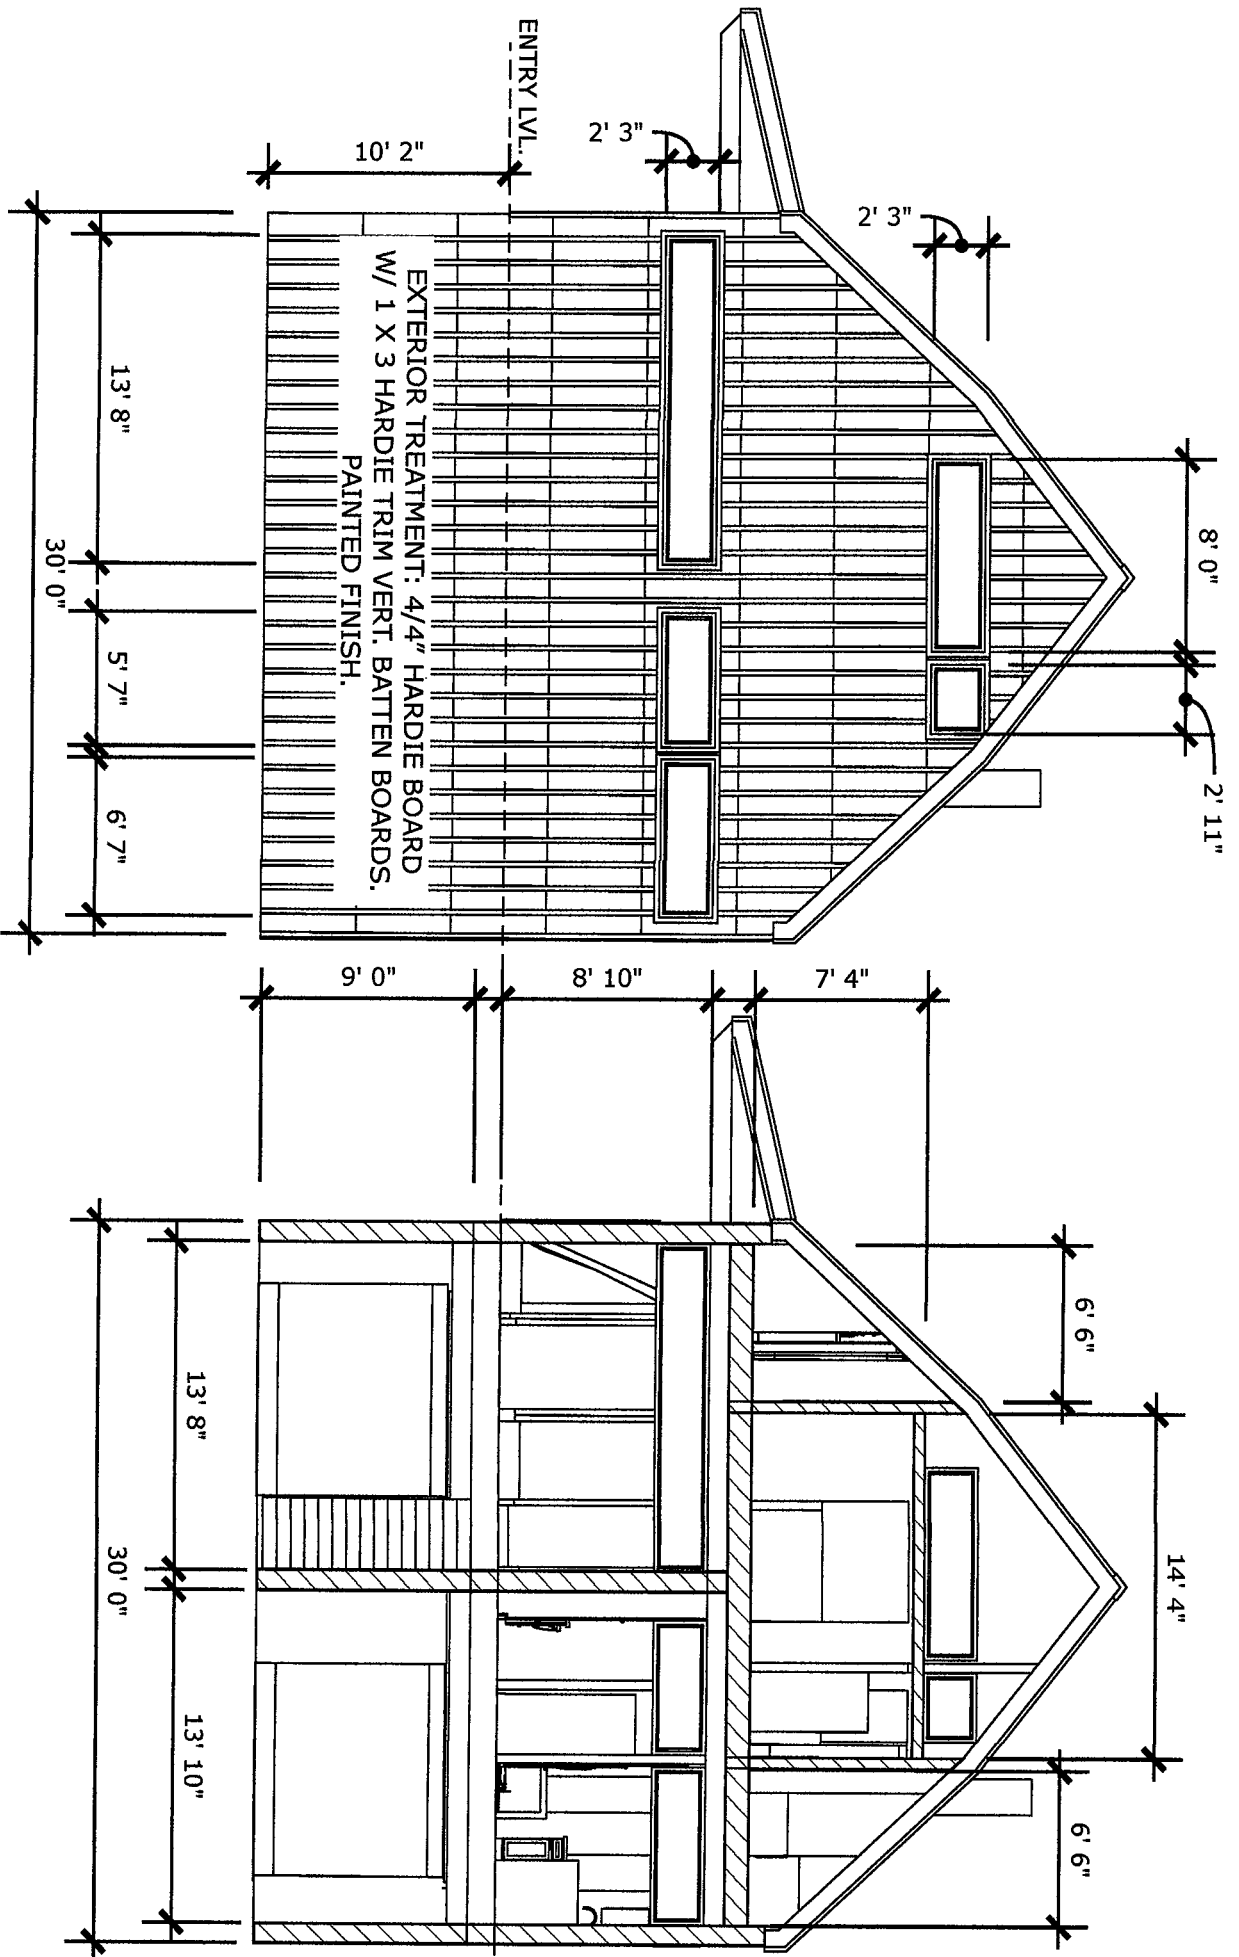
A4

MINK BARN-SOUTH WALL: EXT./INT. ELEVATIONS  
SCALE: 1/8" = 1' 0"
