Tichenor Point Ice Jam- Flood event Pictures

2/24/2016

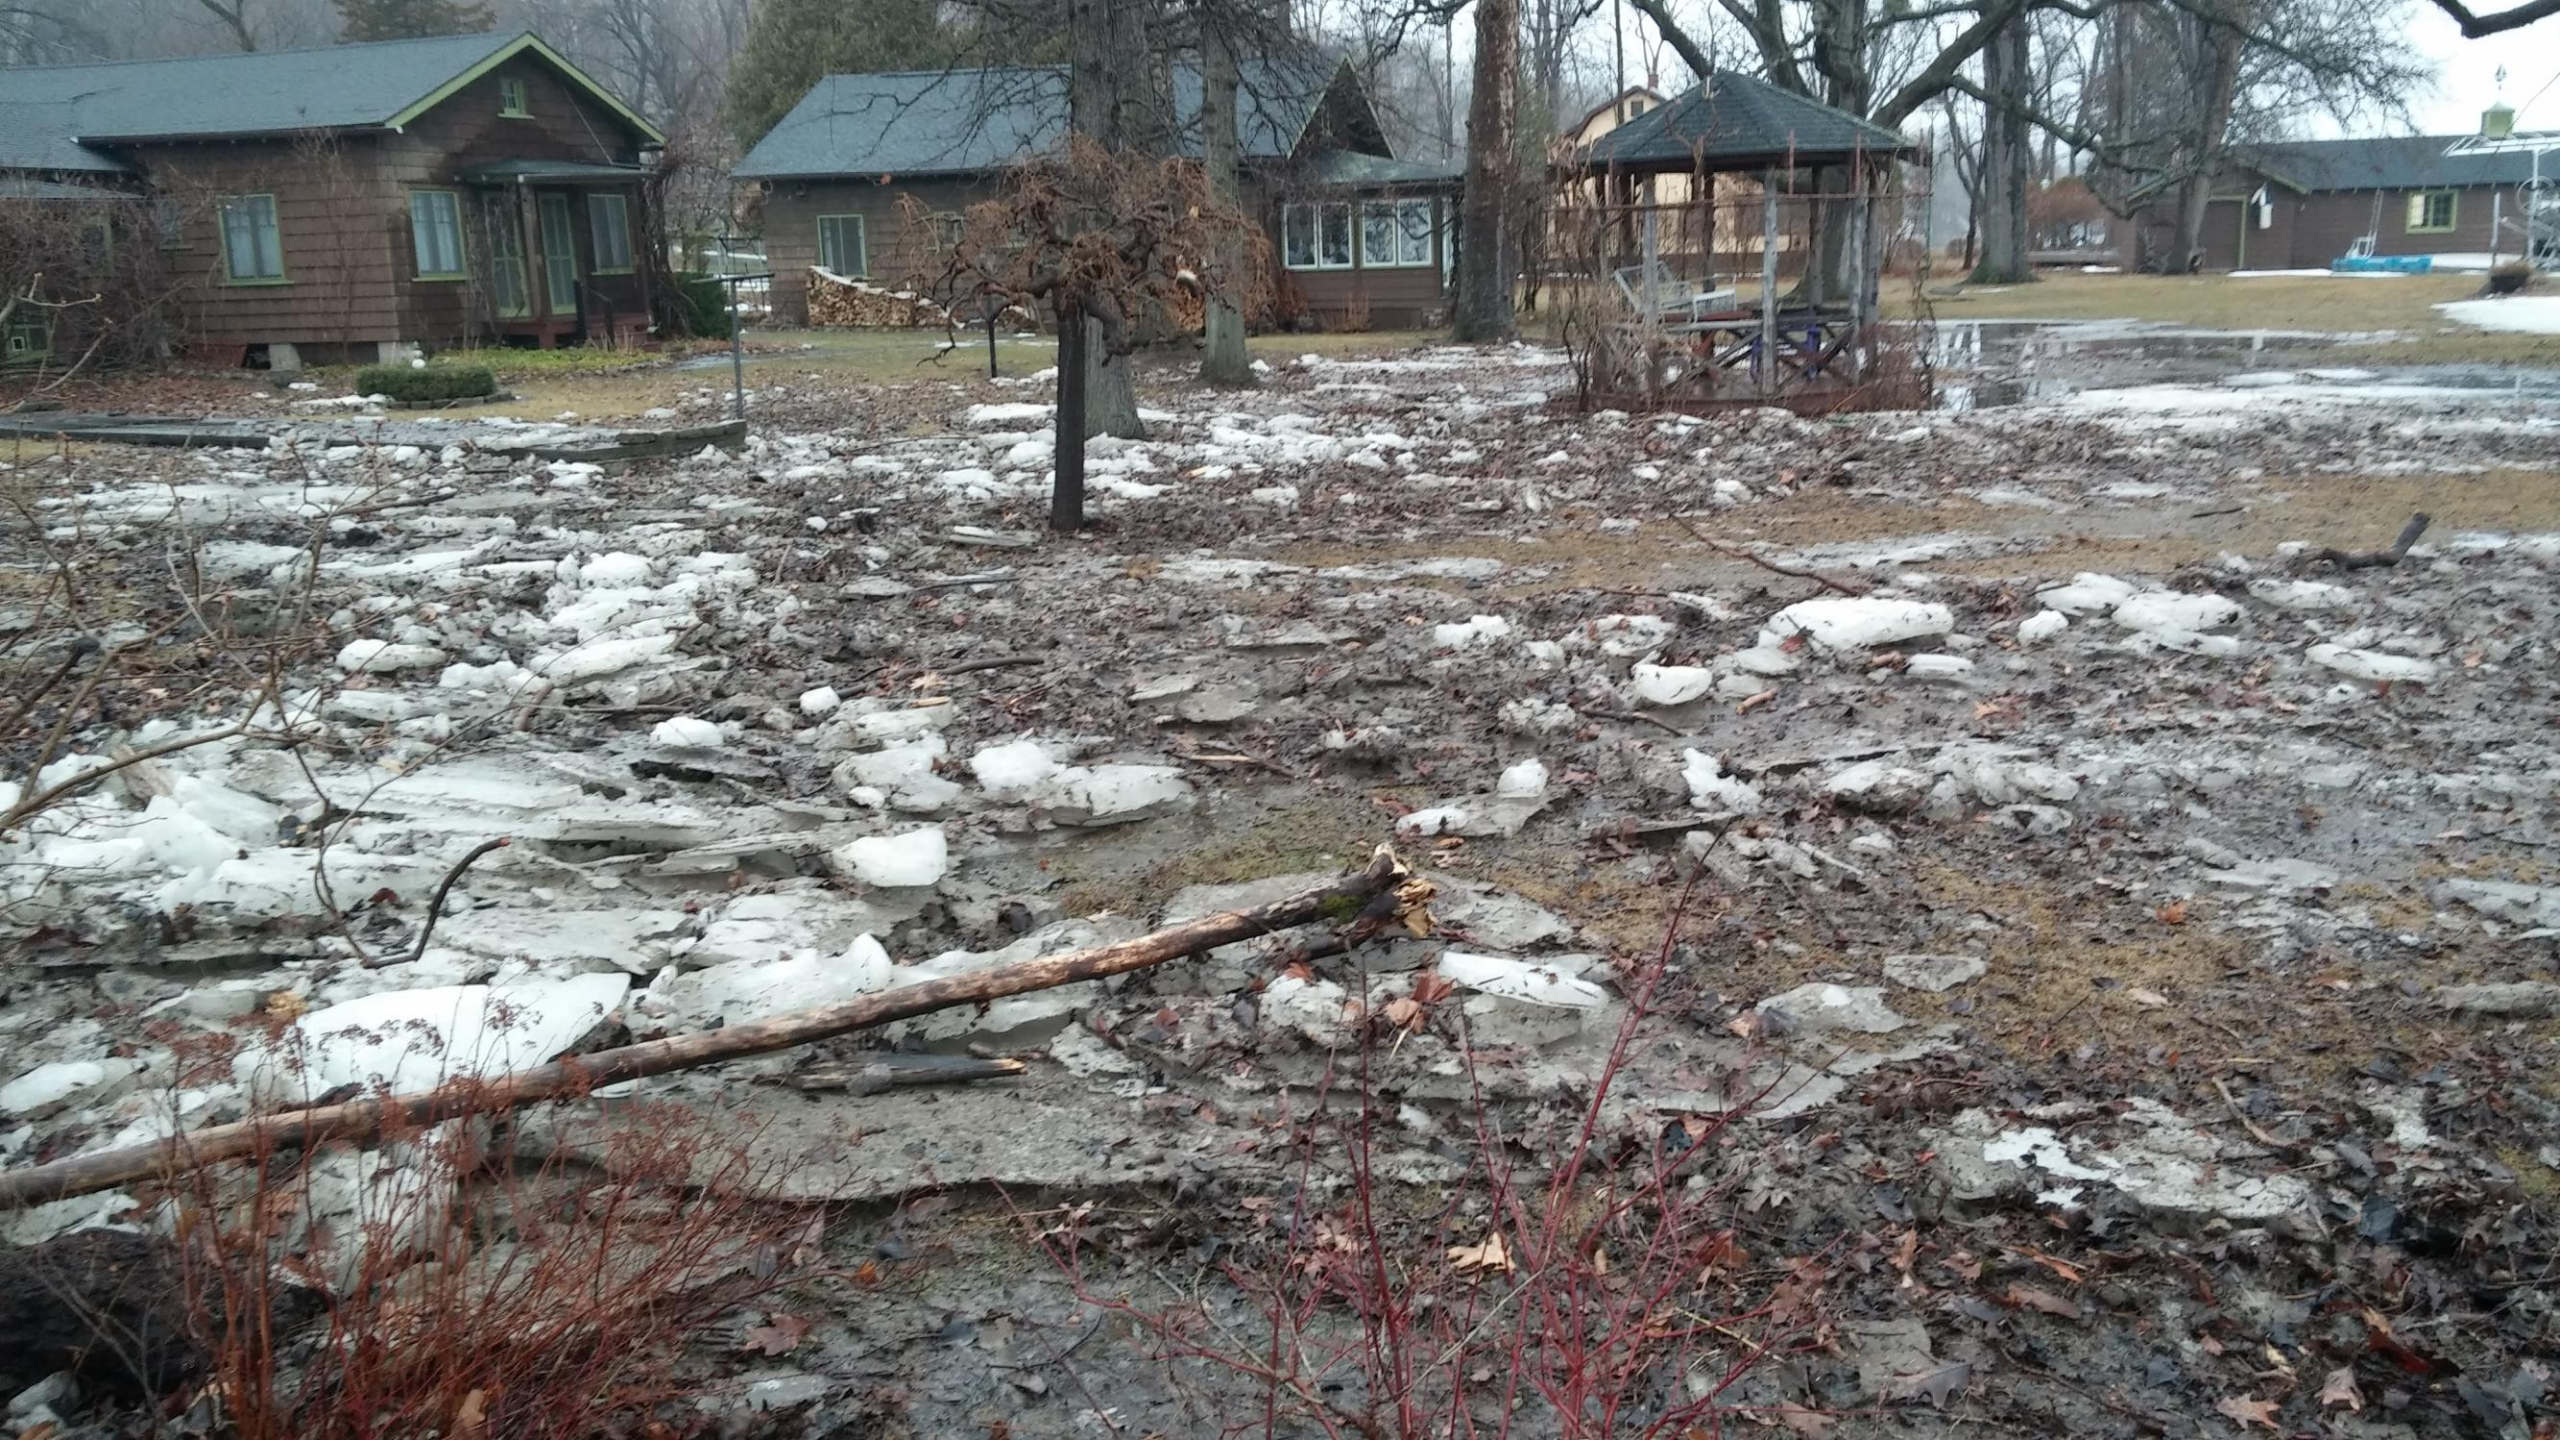
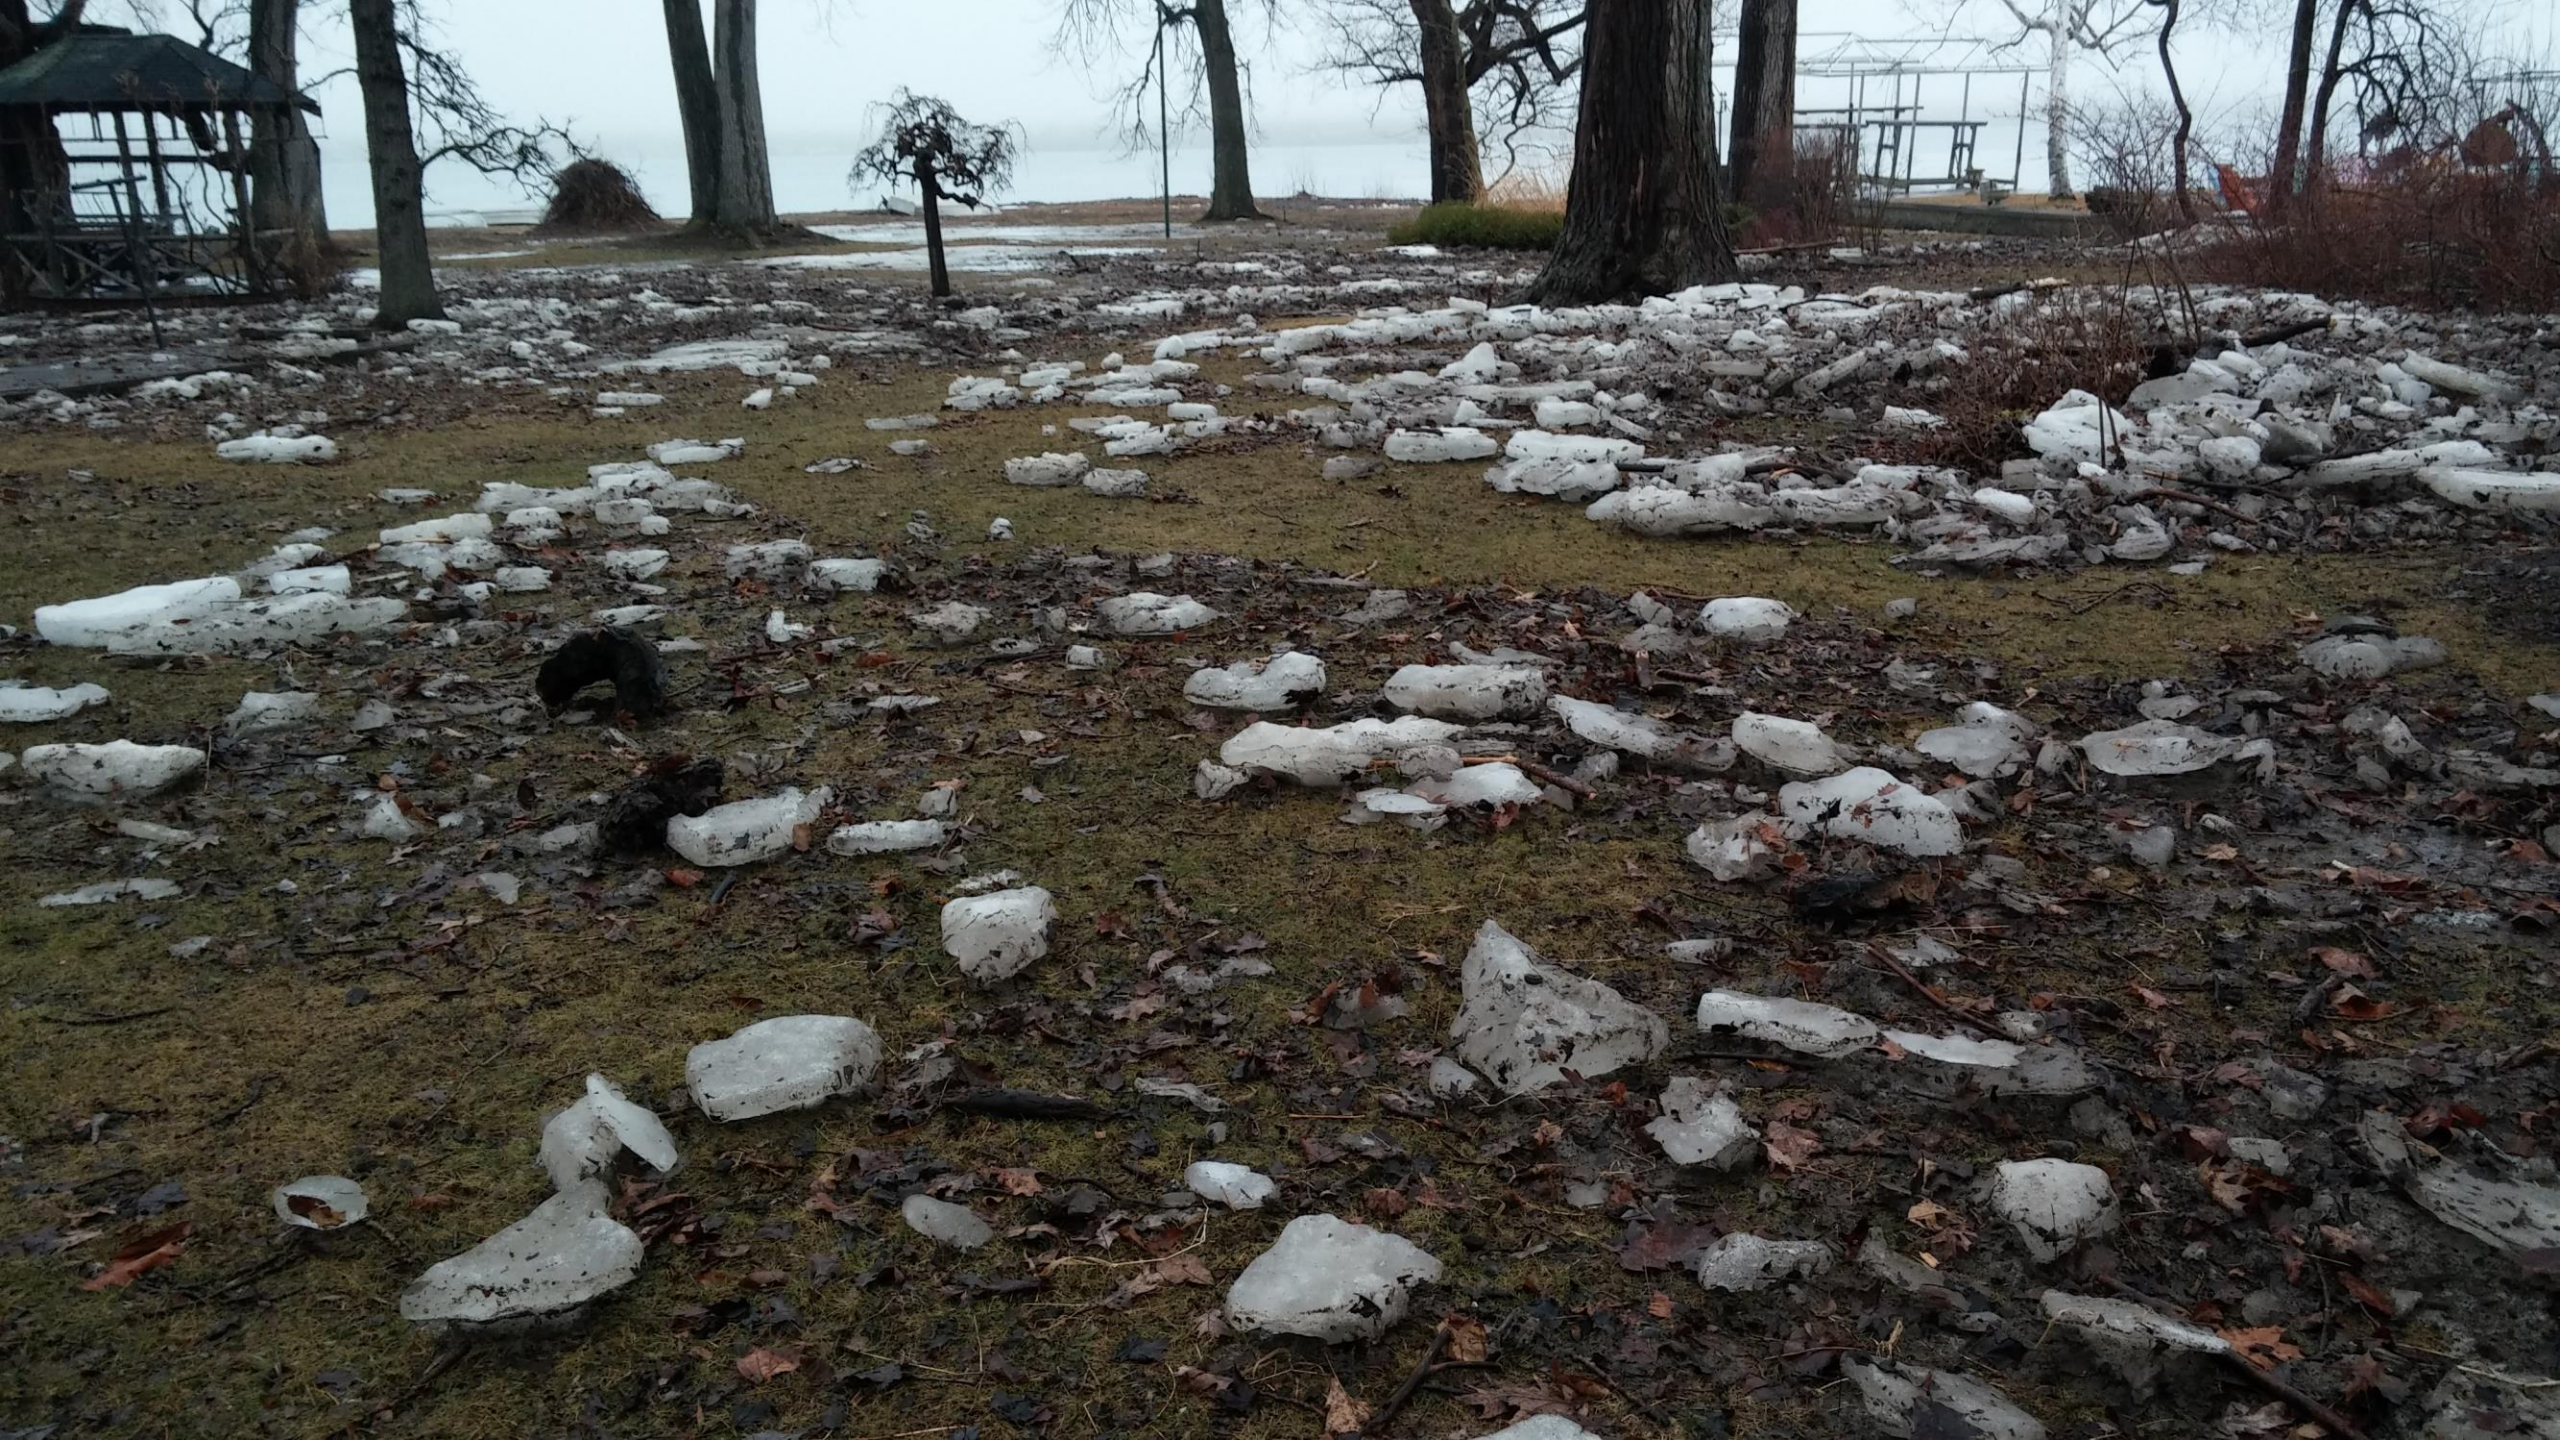
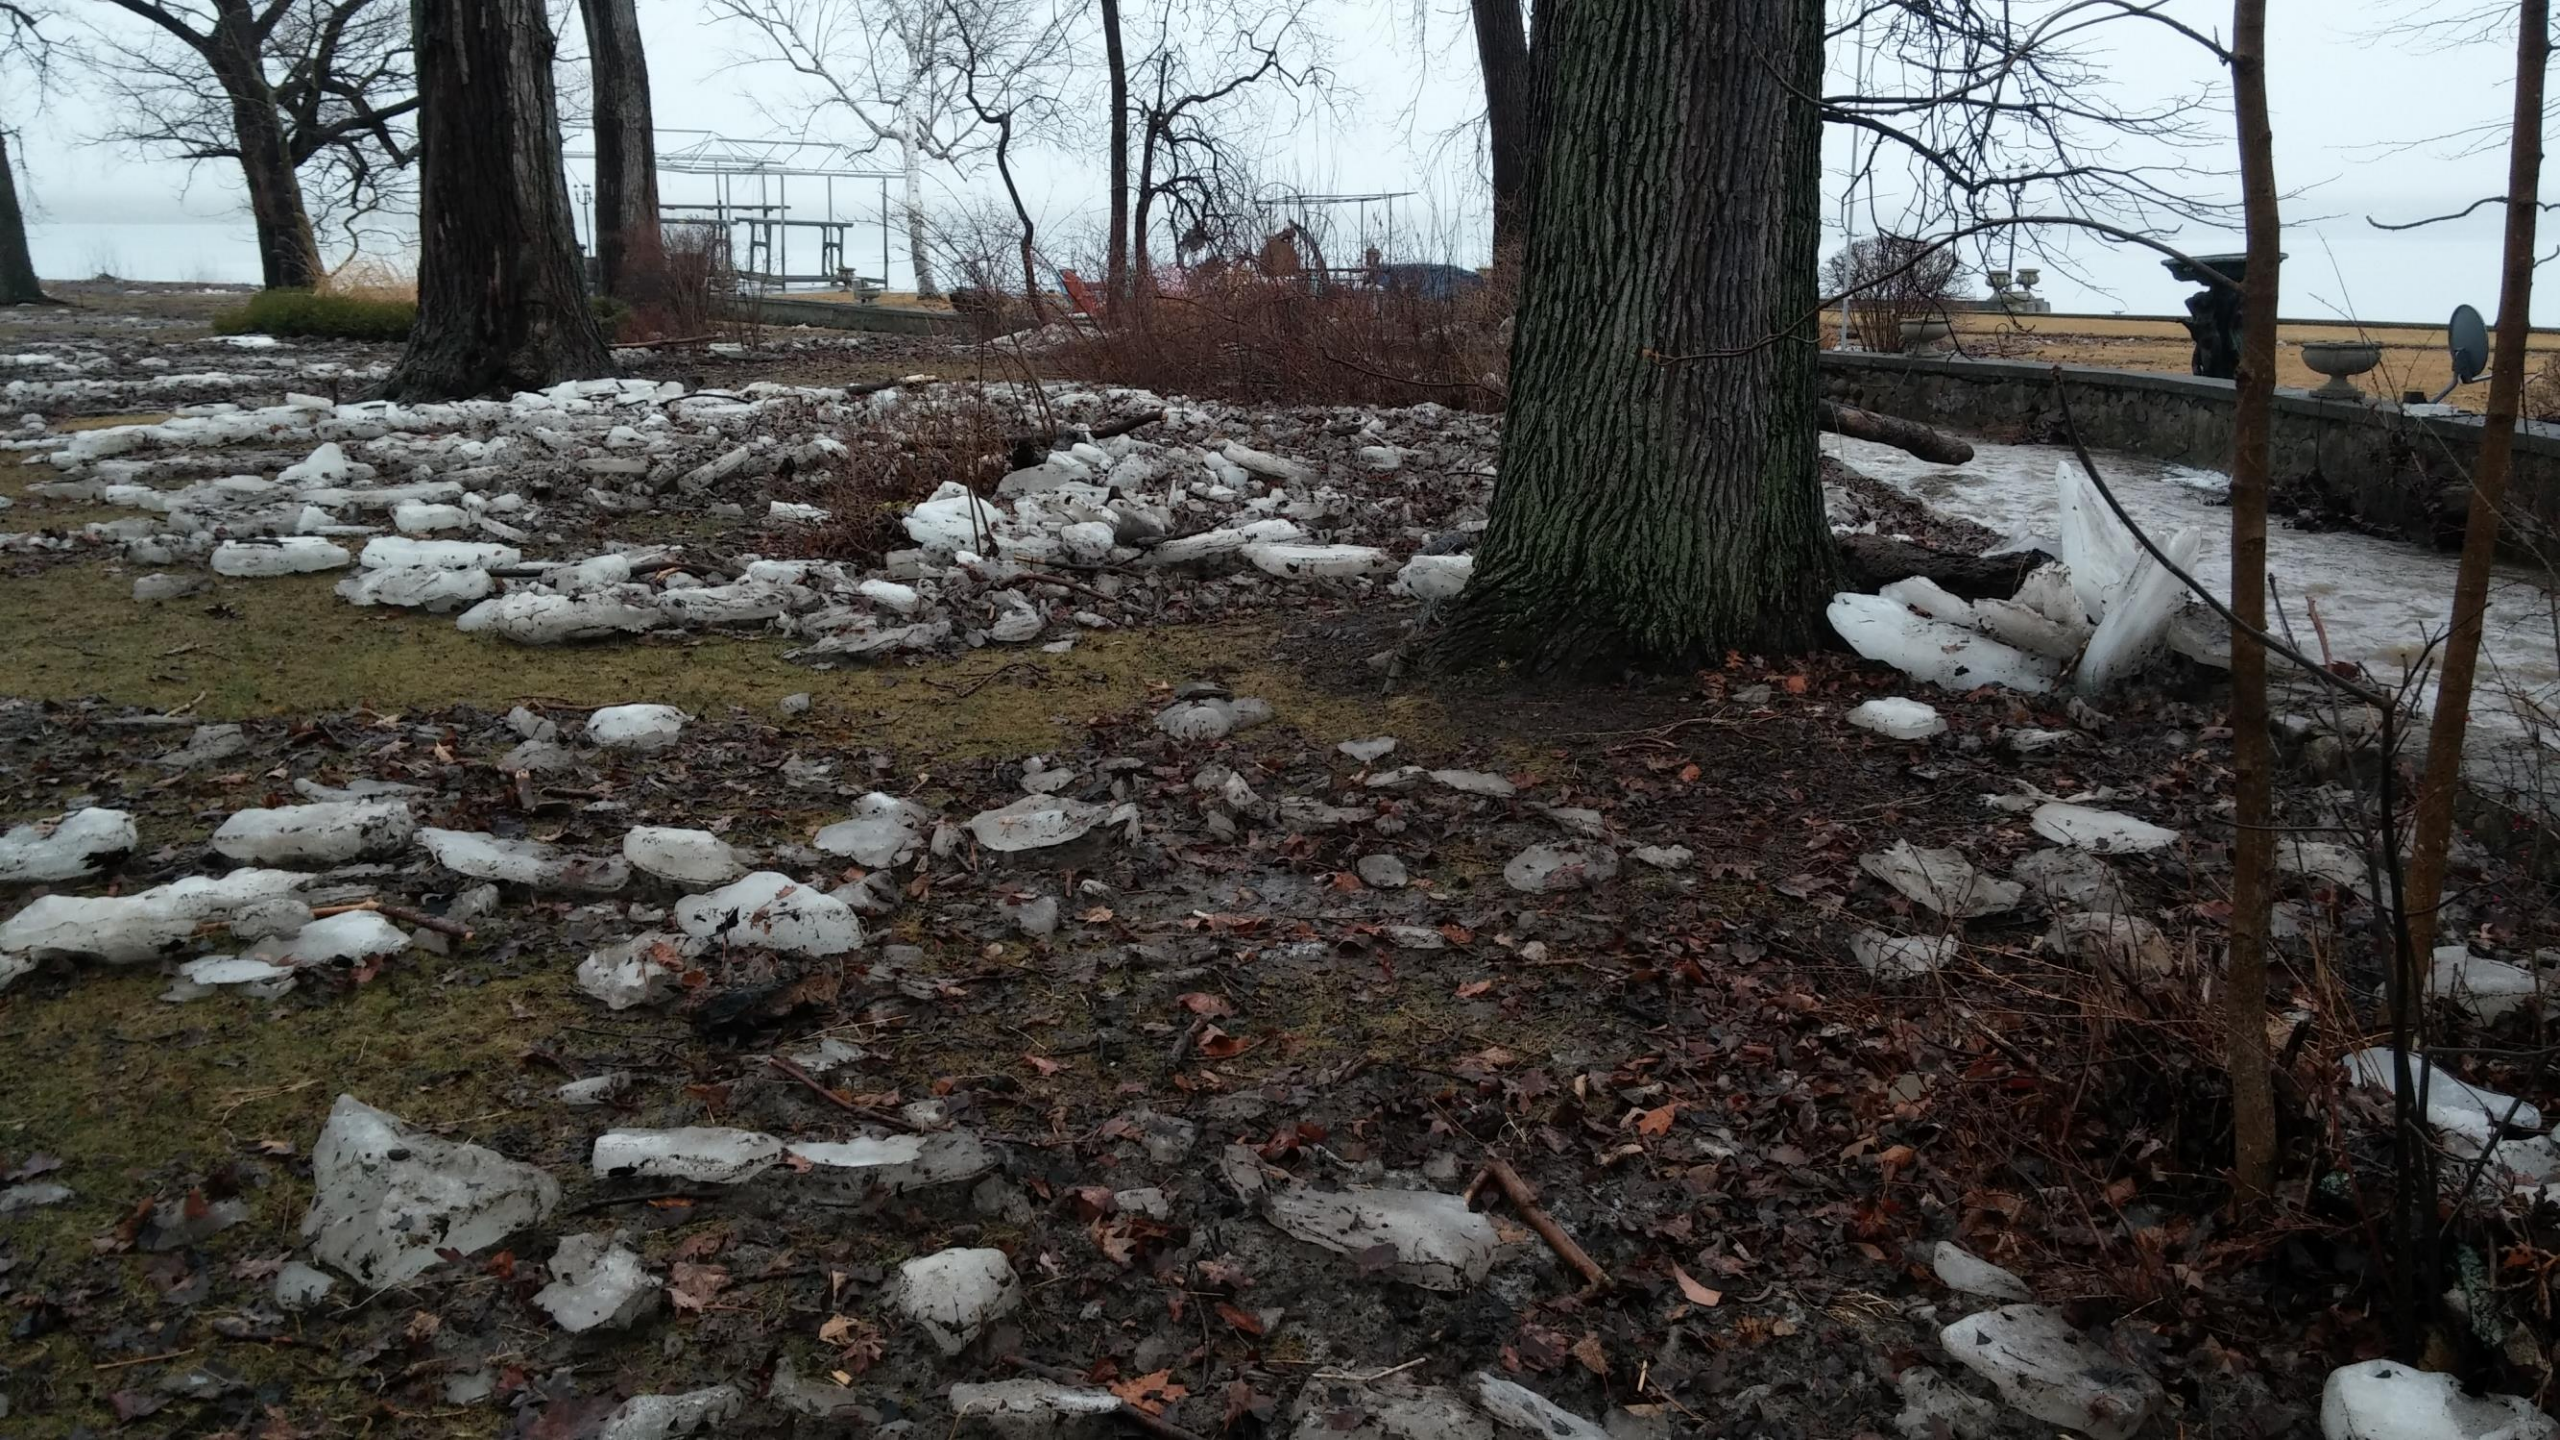
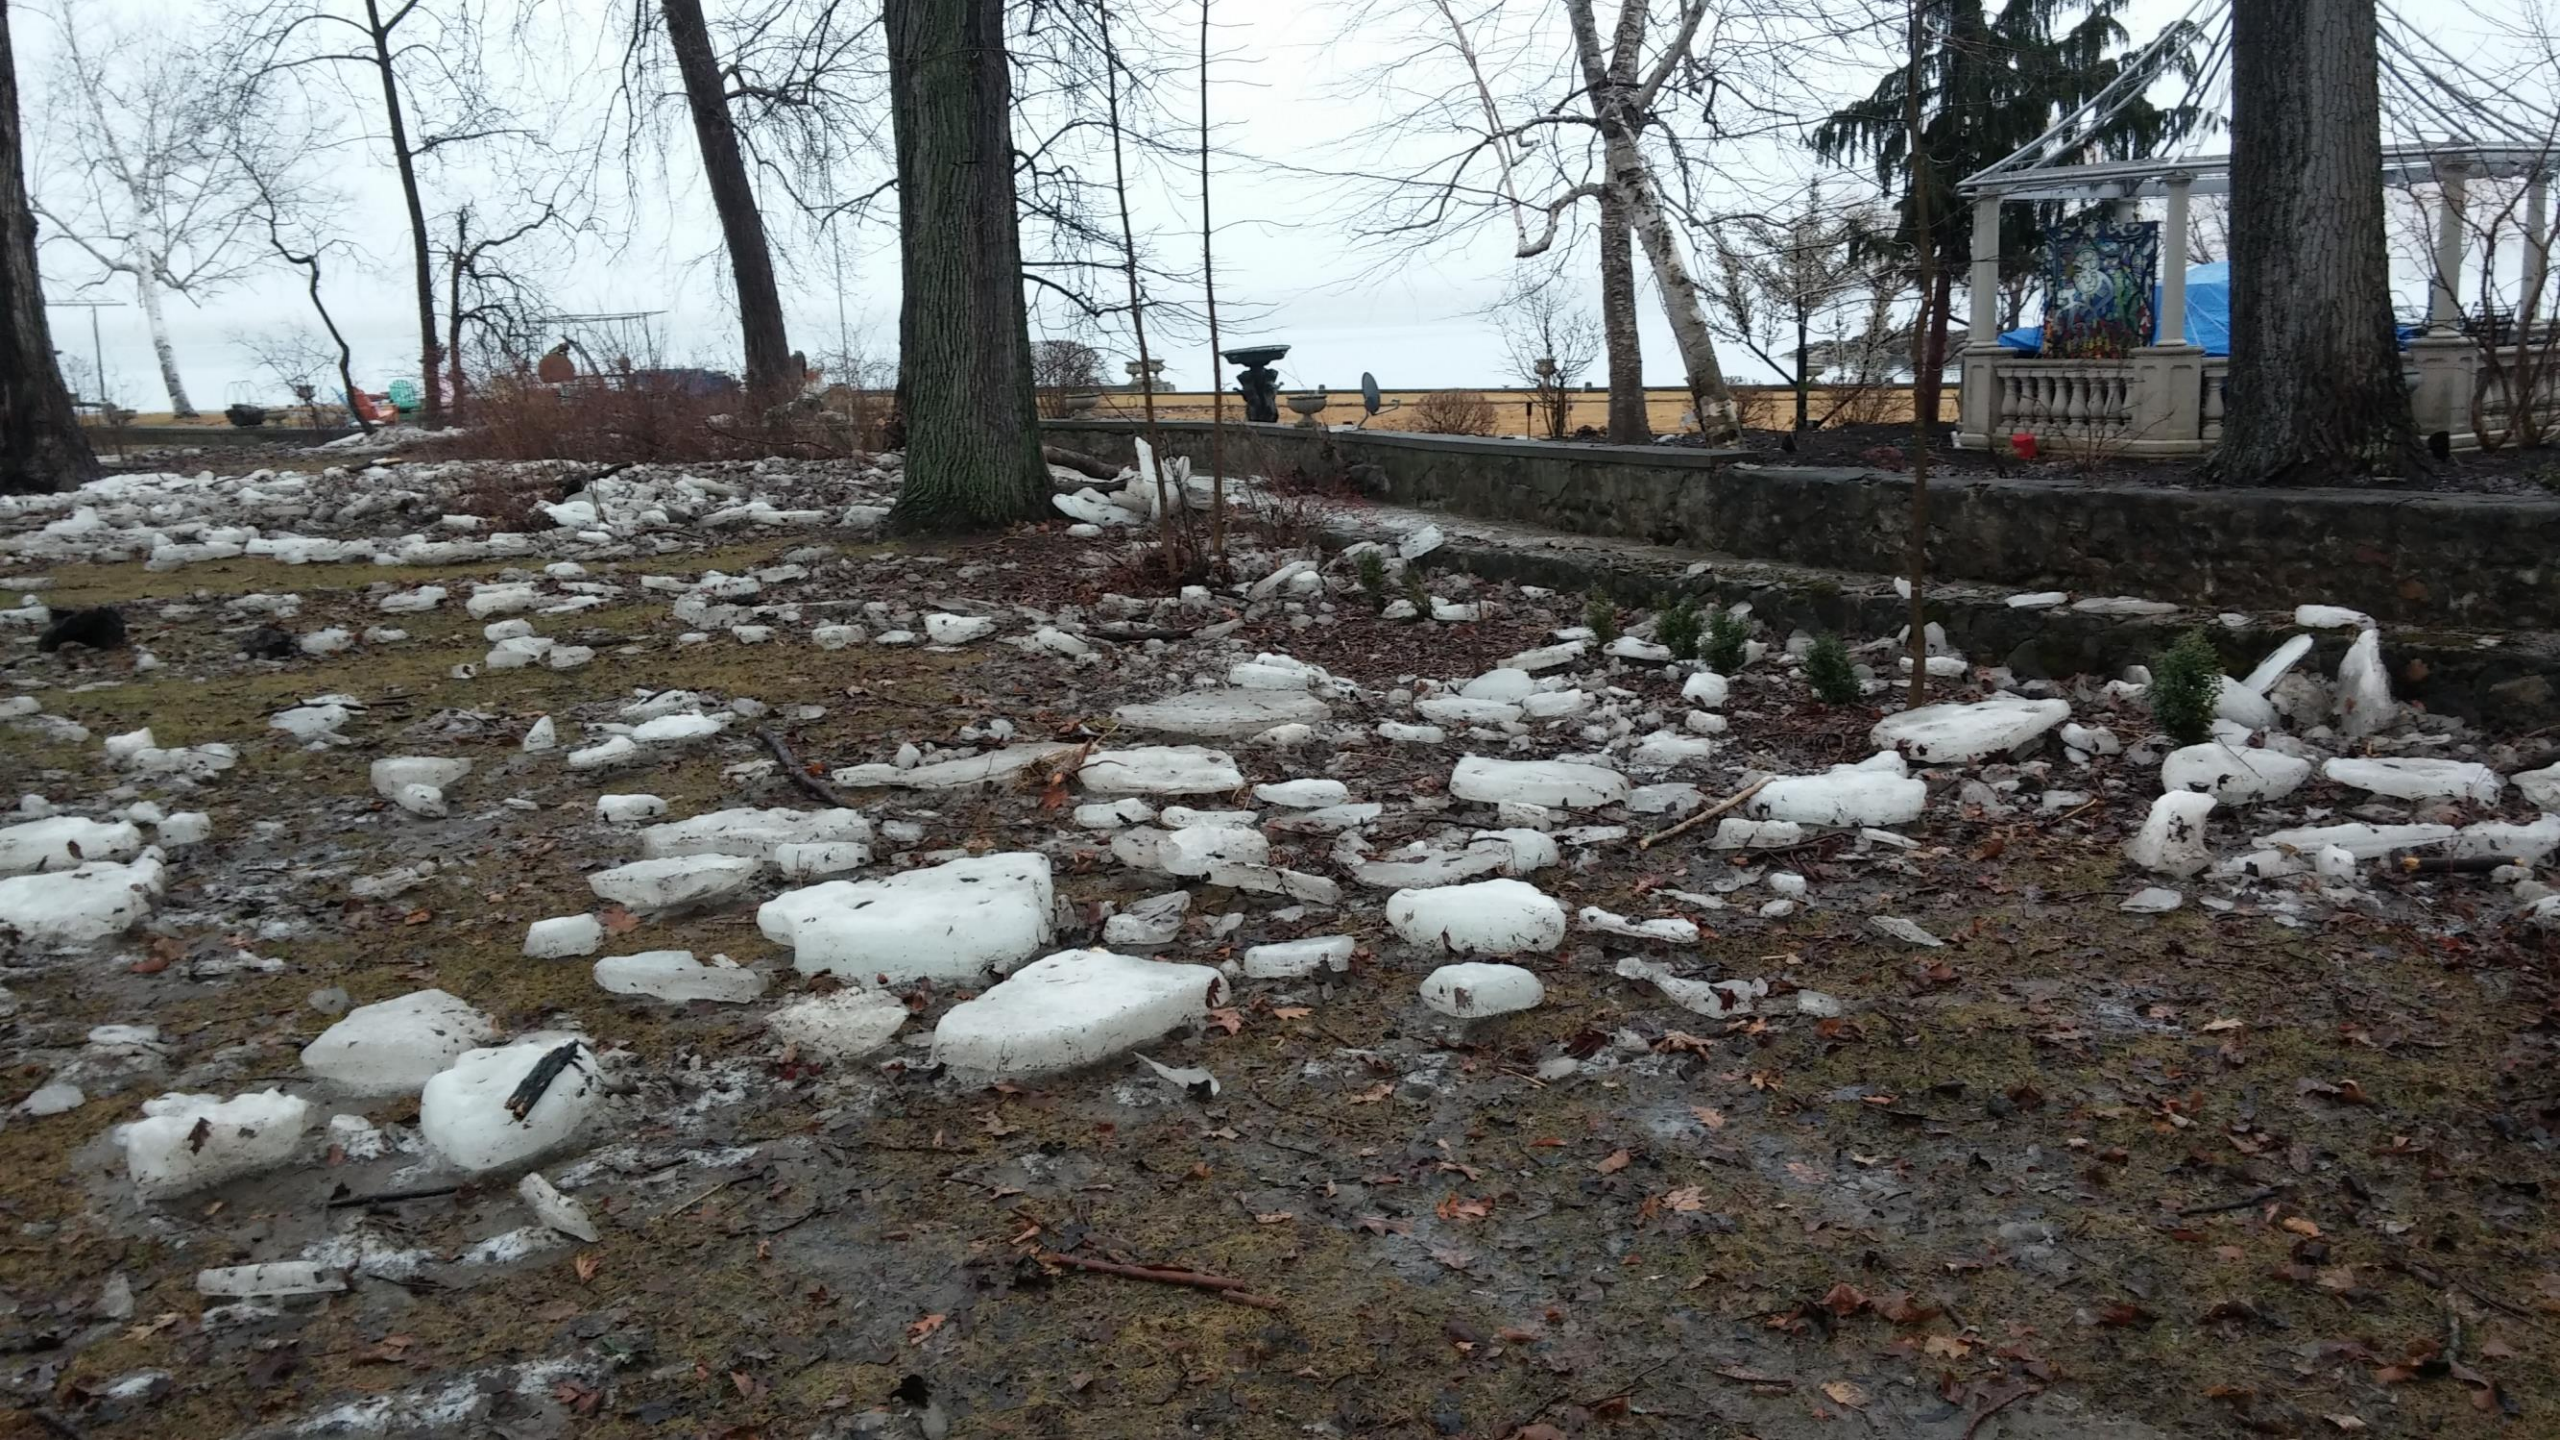
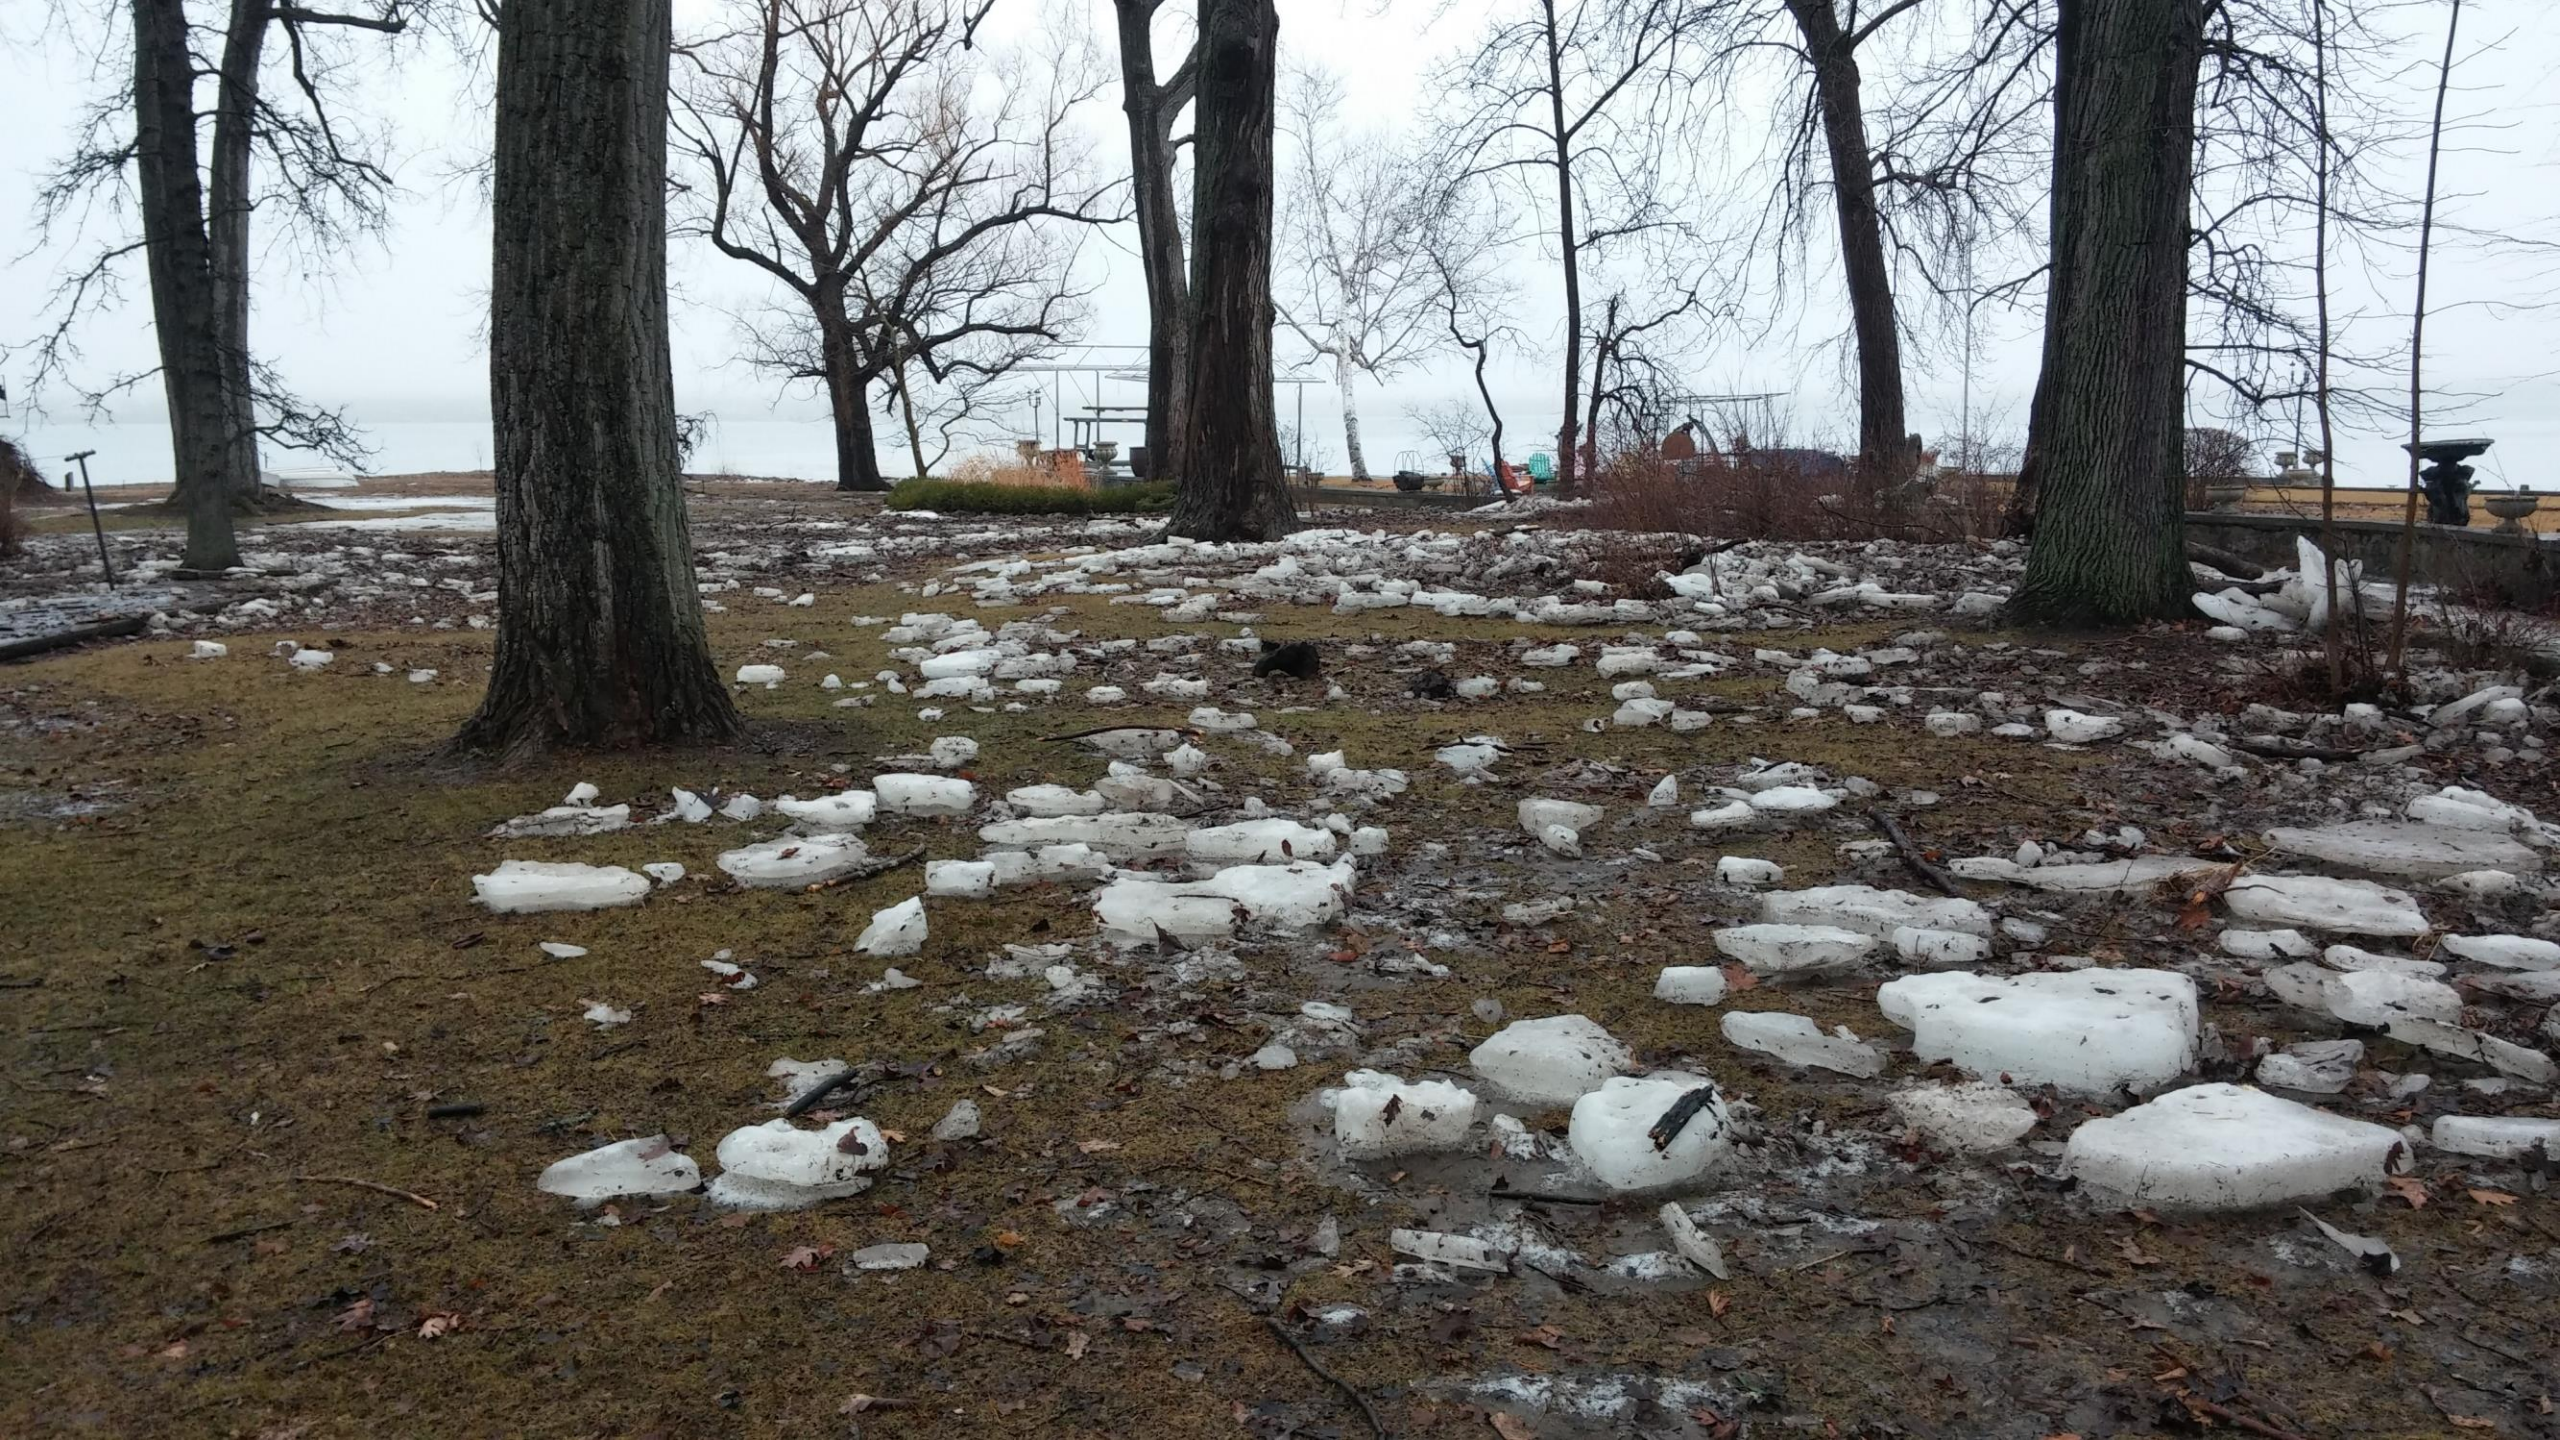
- Ice Jam and Flood event impacting 4351 Tichenor Point Drive
- Was able to find pictures from this event- have seen flooding issues here before
- Proposed southern corner of house, deck and pool location is potentially in the Tichenor Point stream flood pathway.
- May want to consider increasing setback from stream, grading changes or other alternatives that will allow the flood flows to move through this area and not negatively impact the neighbor to the south
